Motorized Sailplanes

20 Years of Joy and Pain

Brief History of Personal Experience since 1986

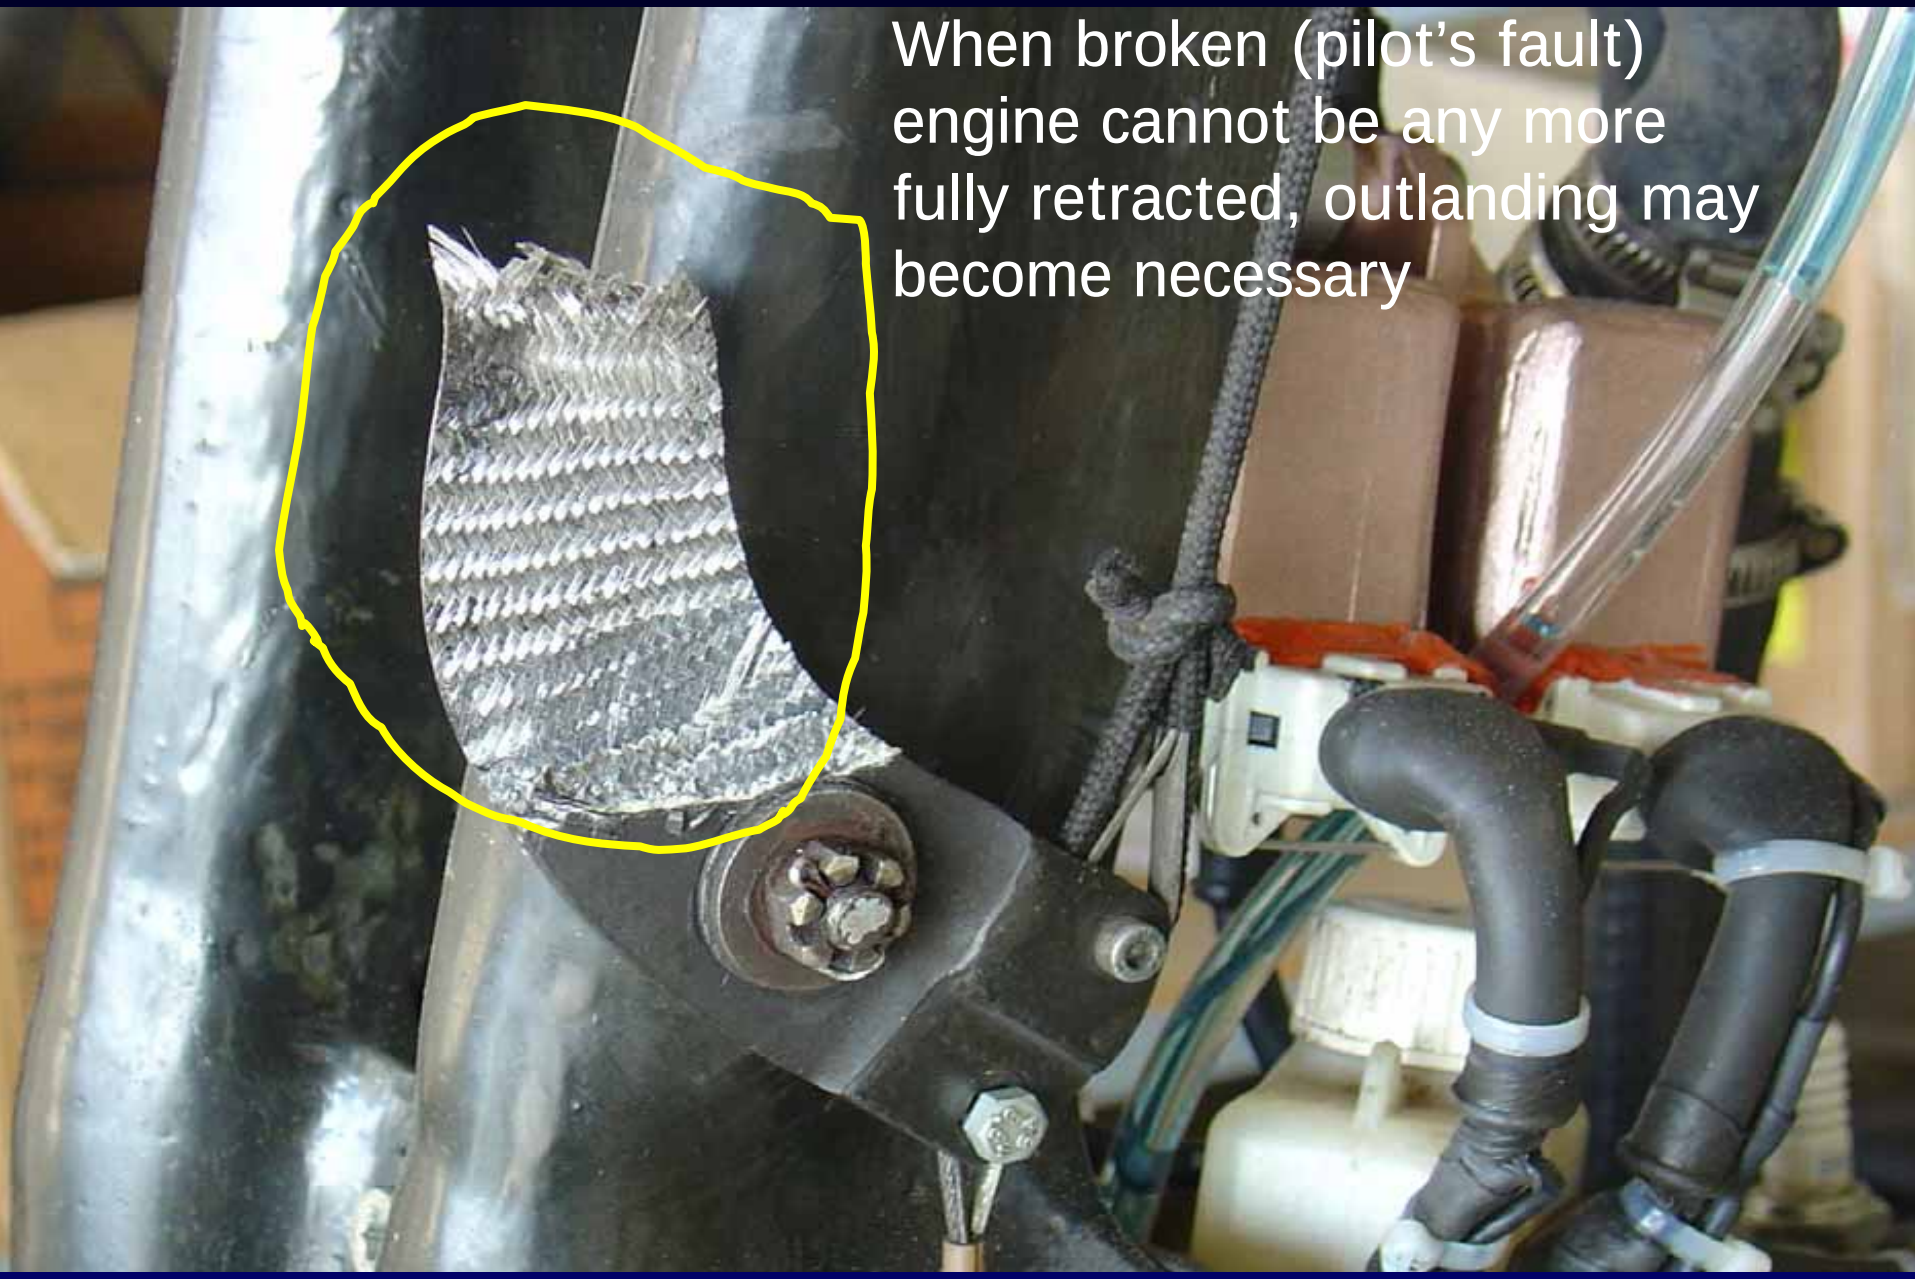
First engine, first problem: One blade is self desintegrating because of speed and vibration (1986)

1. Propeller: the arrestor should be "fault tolerant", otherwise the problem becomes worse (new desing is OK)

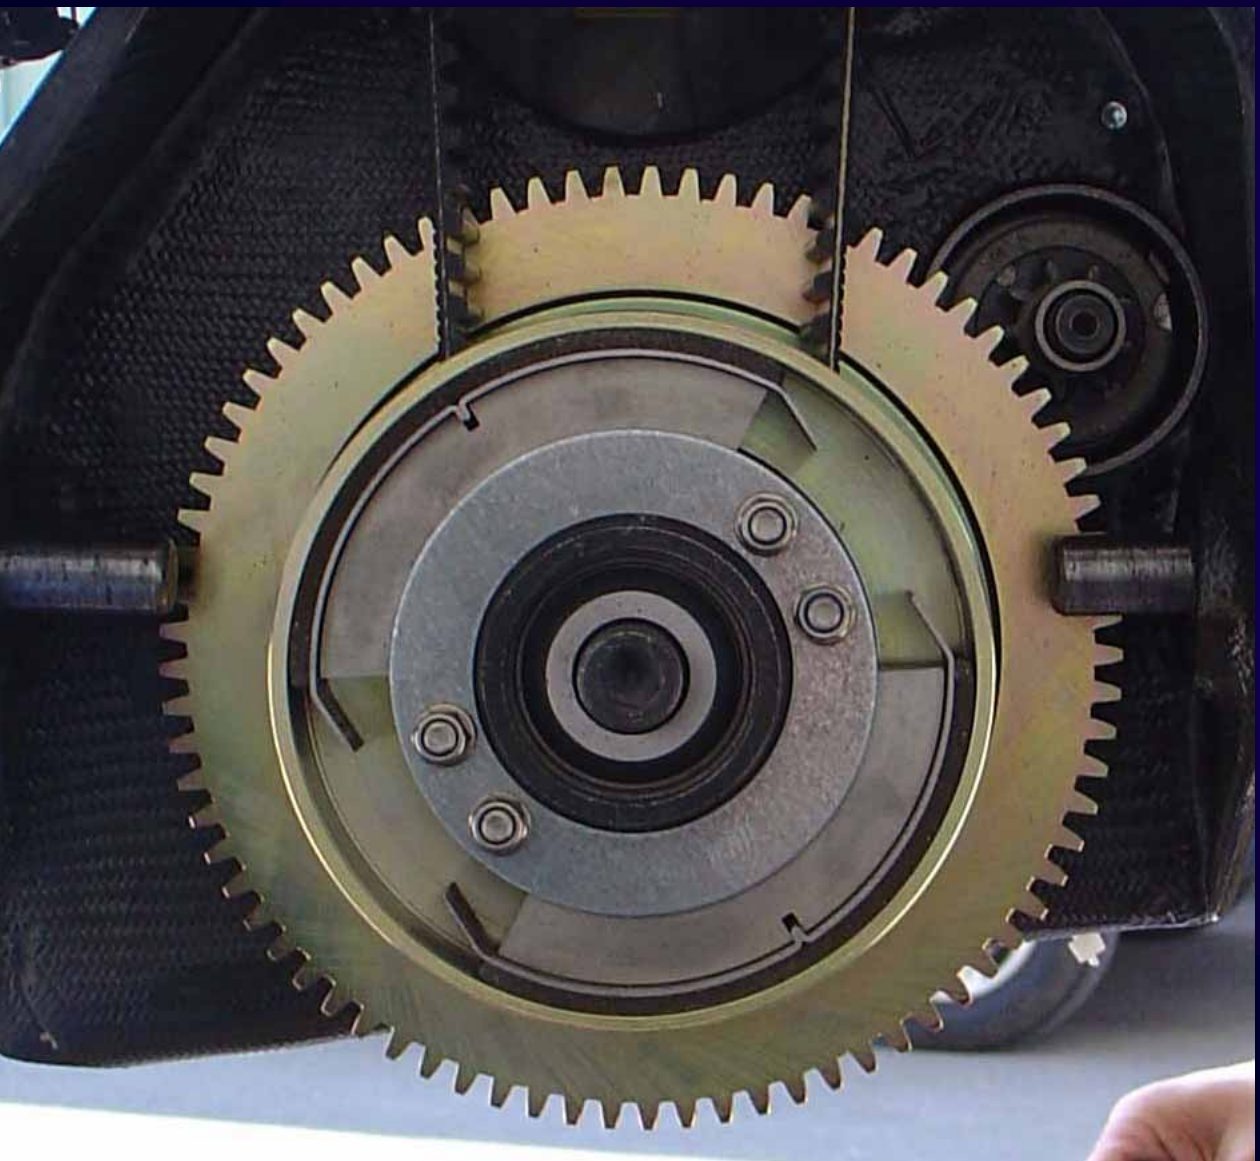
All Solo engines

The centrifugal friction is a costly and heavy solution

Problem was also solved using the original and more flexible10 years old design fiberglass tooth belt.

But setting of tension is difficult because of too short available adjustment travel.

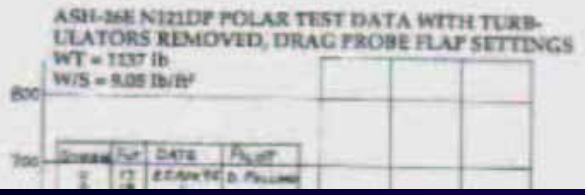
It was during this testing period that the ASH-26 suffered a propulsion system failure, and we had to resort to aero towing to finish the testing. The engine itself did not fail, but a sealed propeller drive belt idler pulley bearing failed, causing a sudden and complete loss of propeller thrust. The cause of the bearing failure was not determined. The engine had been operated only about 18 hours total time before the bearing failed. The ASH-26 was equipped with both a nose and a CG tow hooks, so most of the testing was able to continue uninterrupted.

ASH26E: The belt drive failed during the test flight by Dick Johnson in 1995.
Only 18 hours since new...

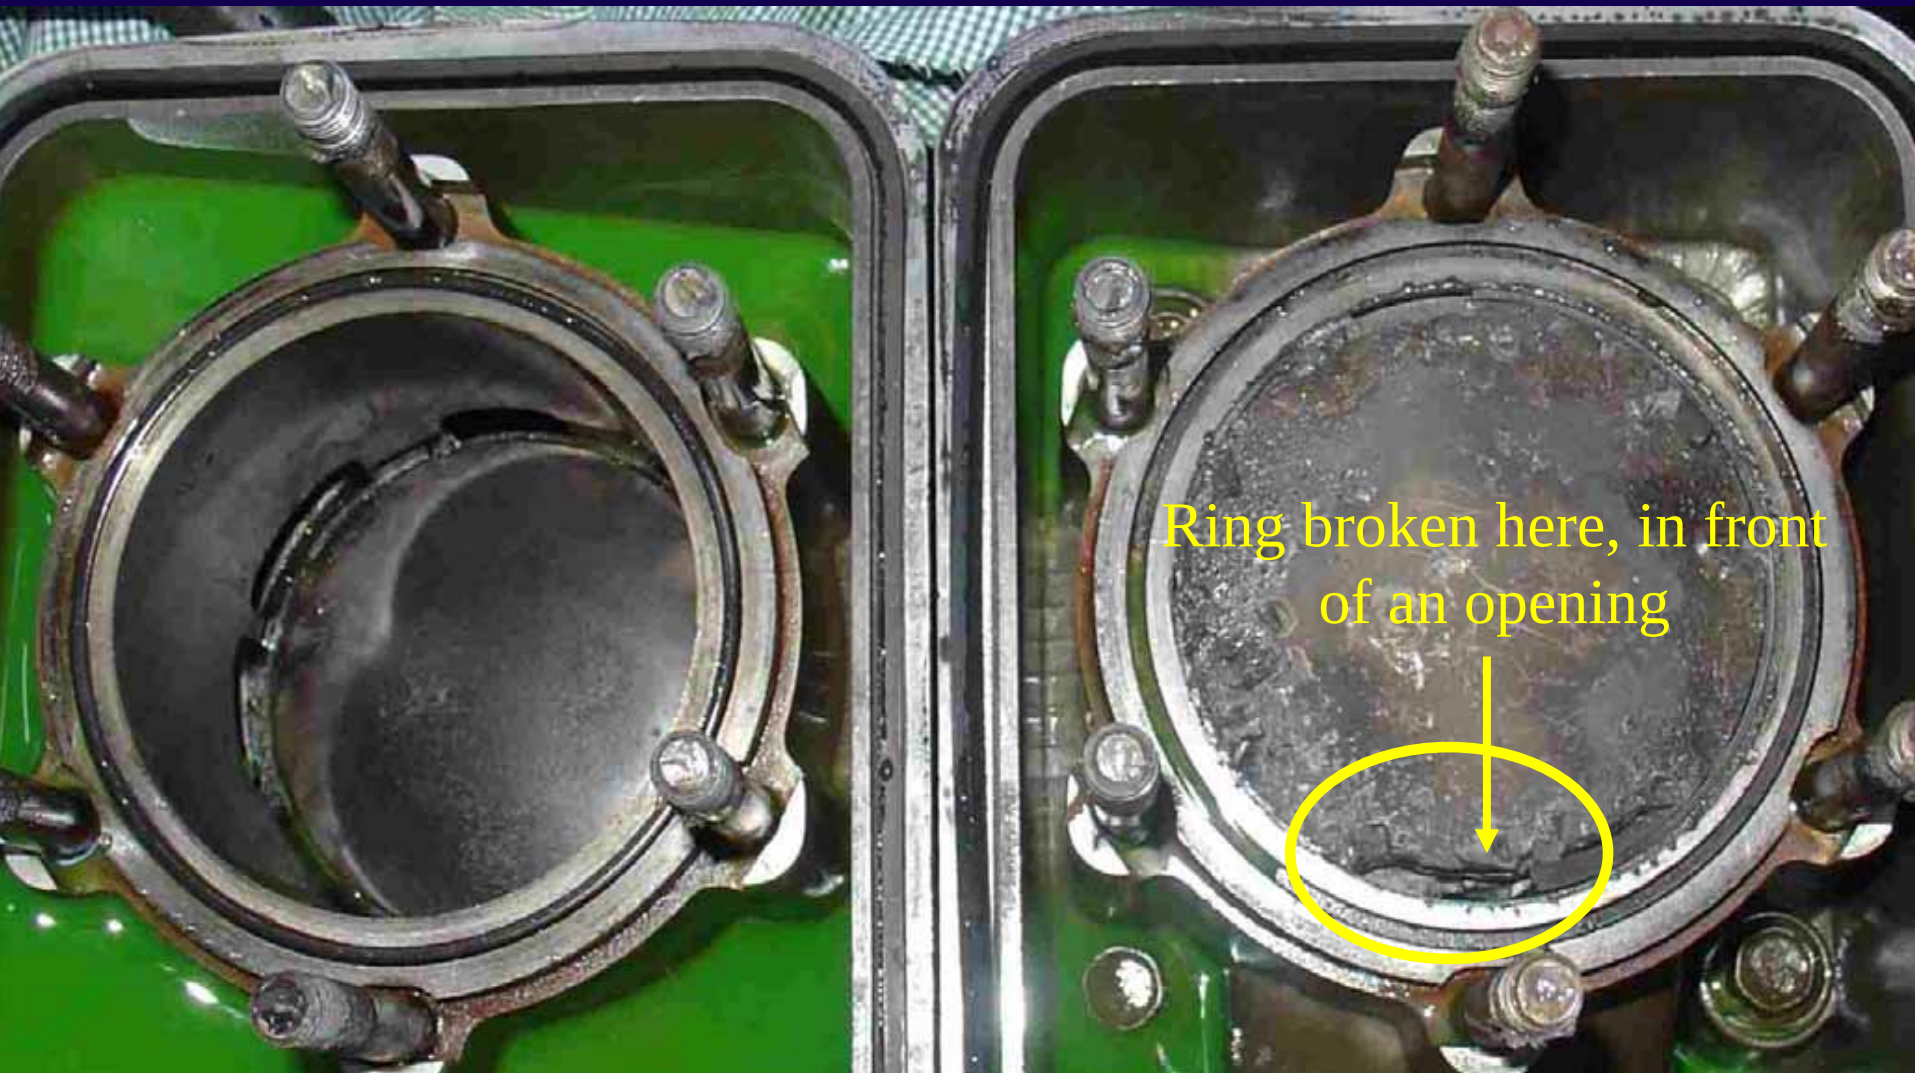
Rotax 535 Piston Ring position error and result (25 hours since supposedly new)

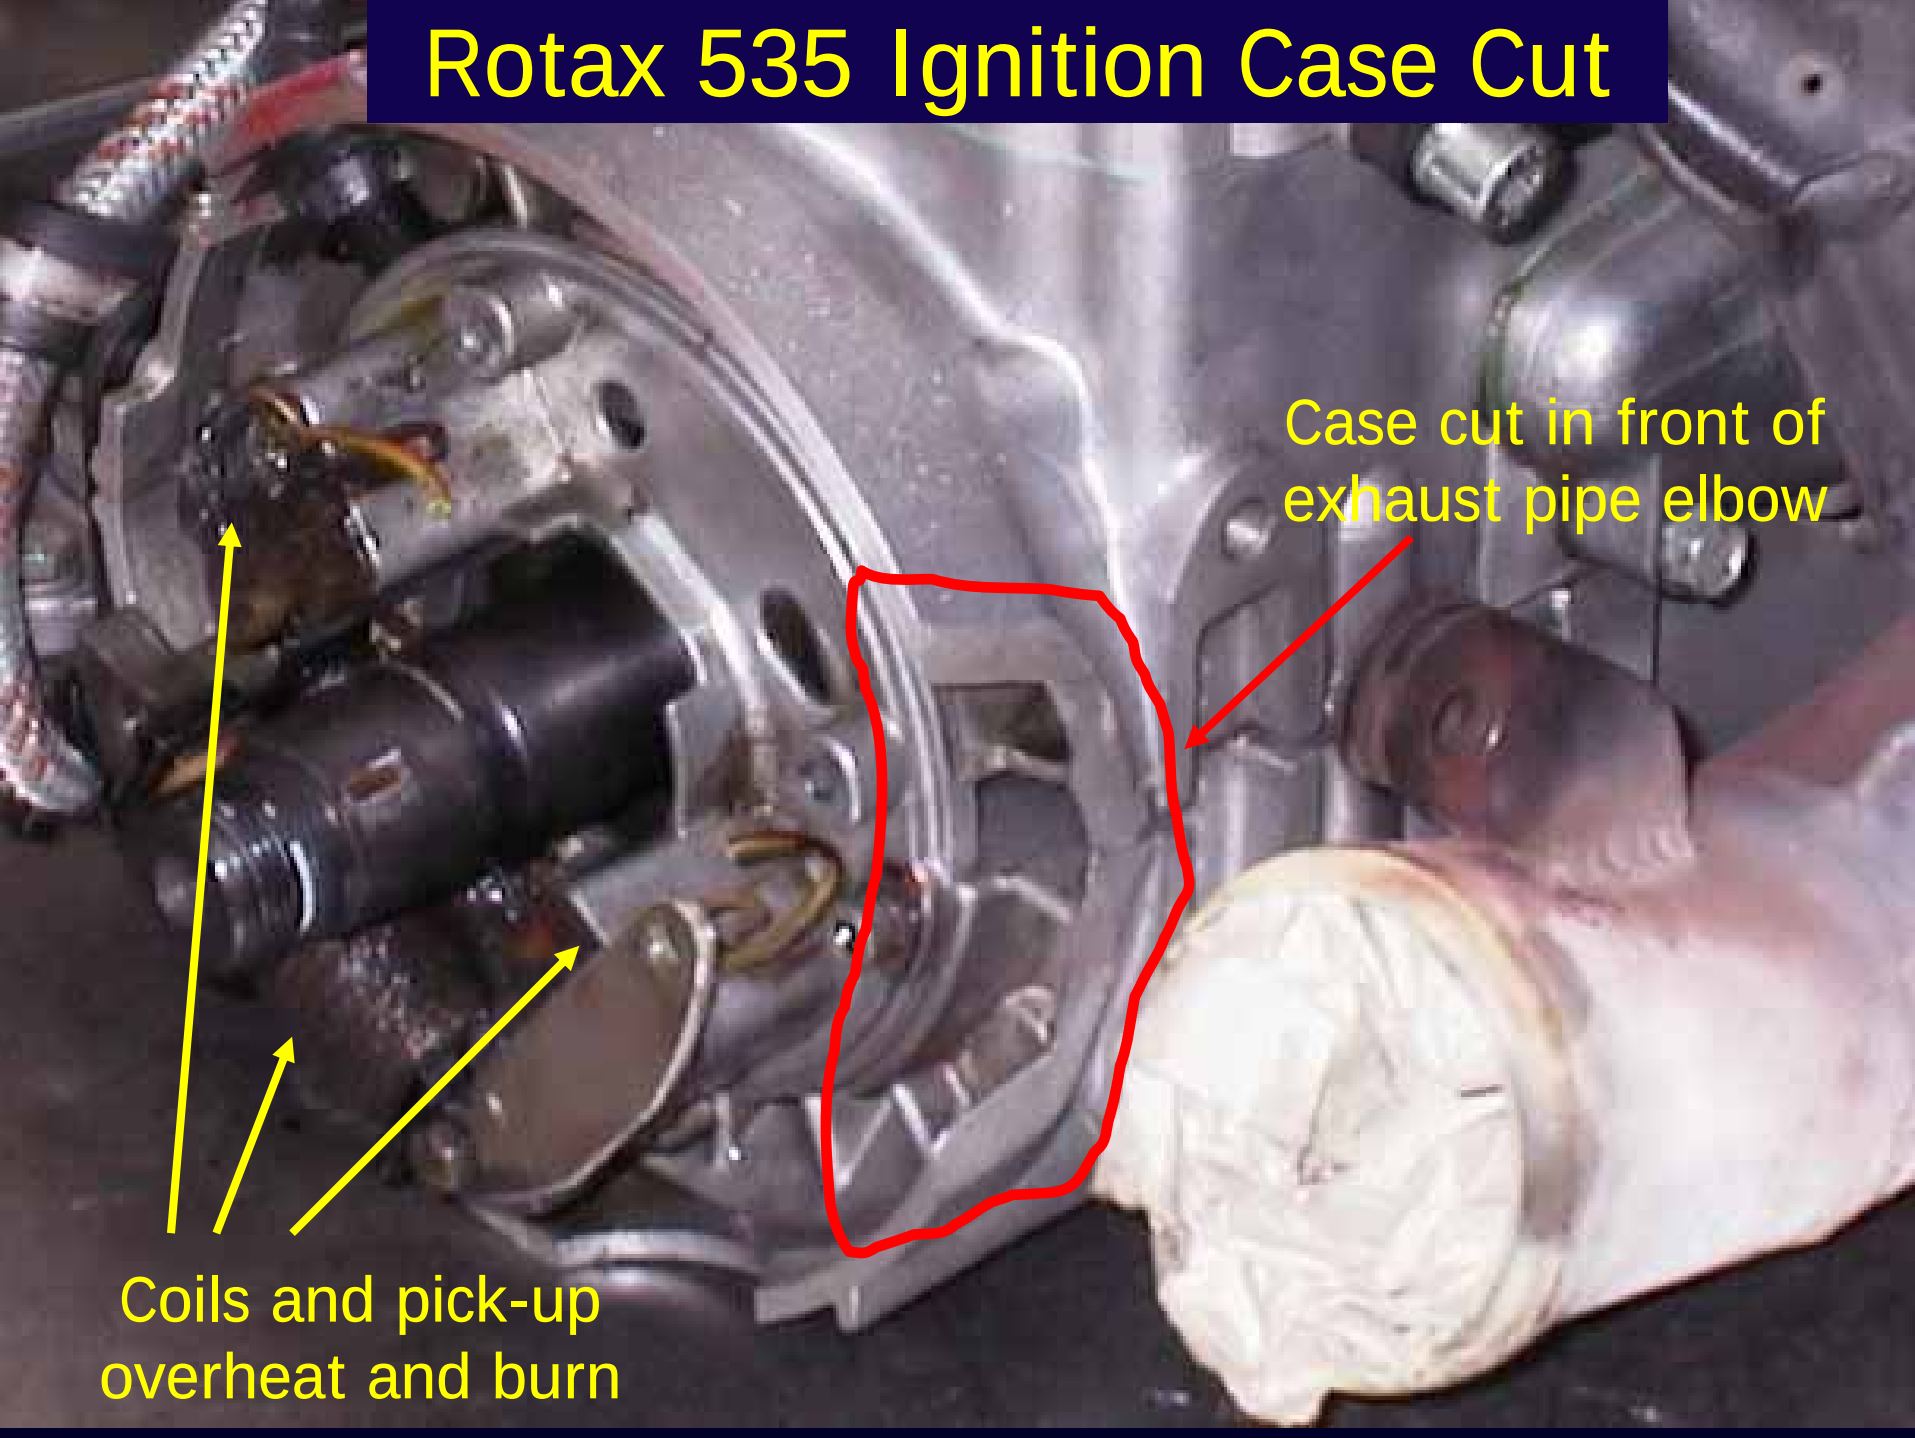
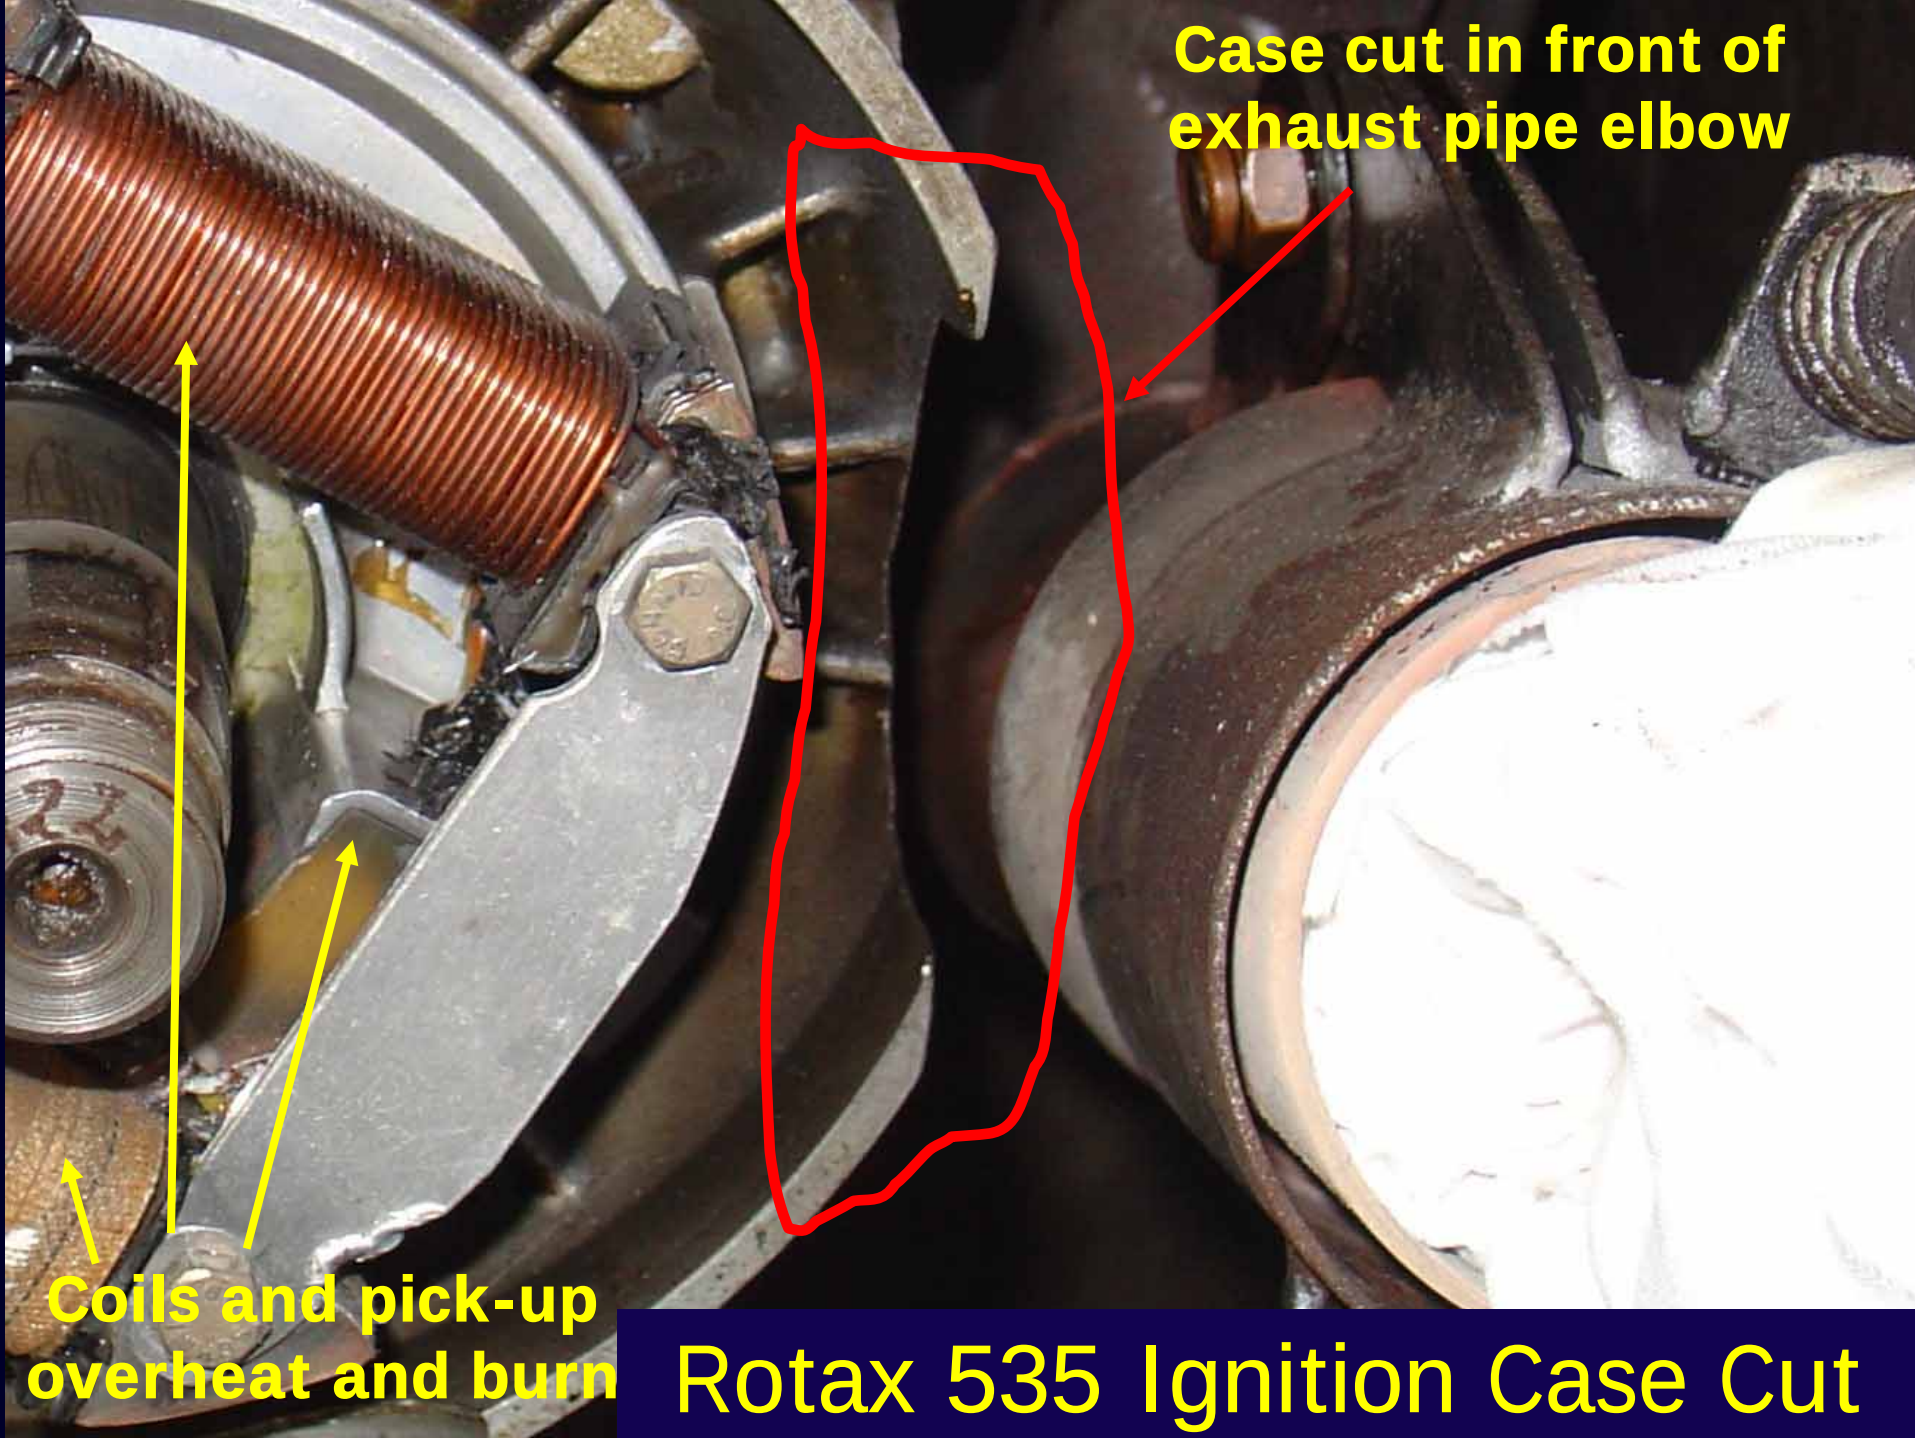
Rotax 535 Oil Tube leakage

Rotax 535 Ignition Case Cut

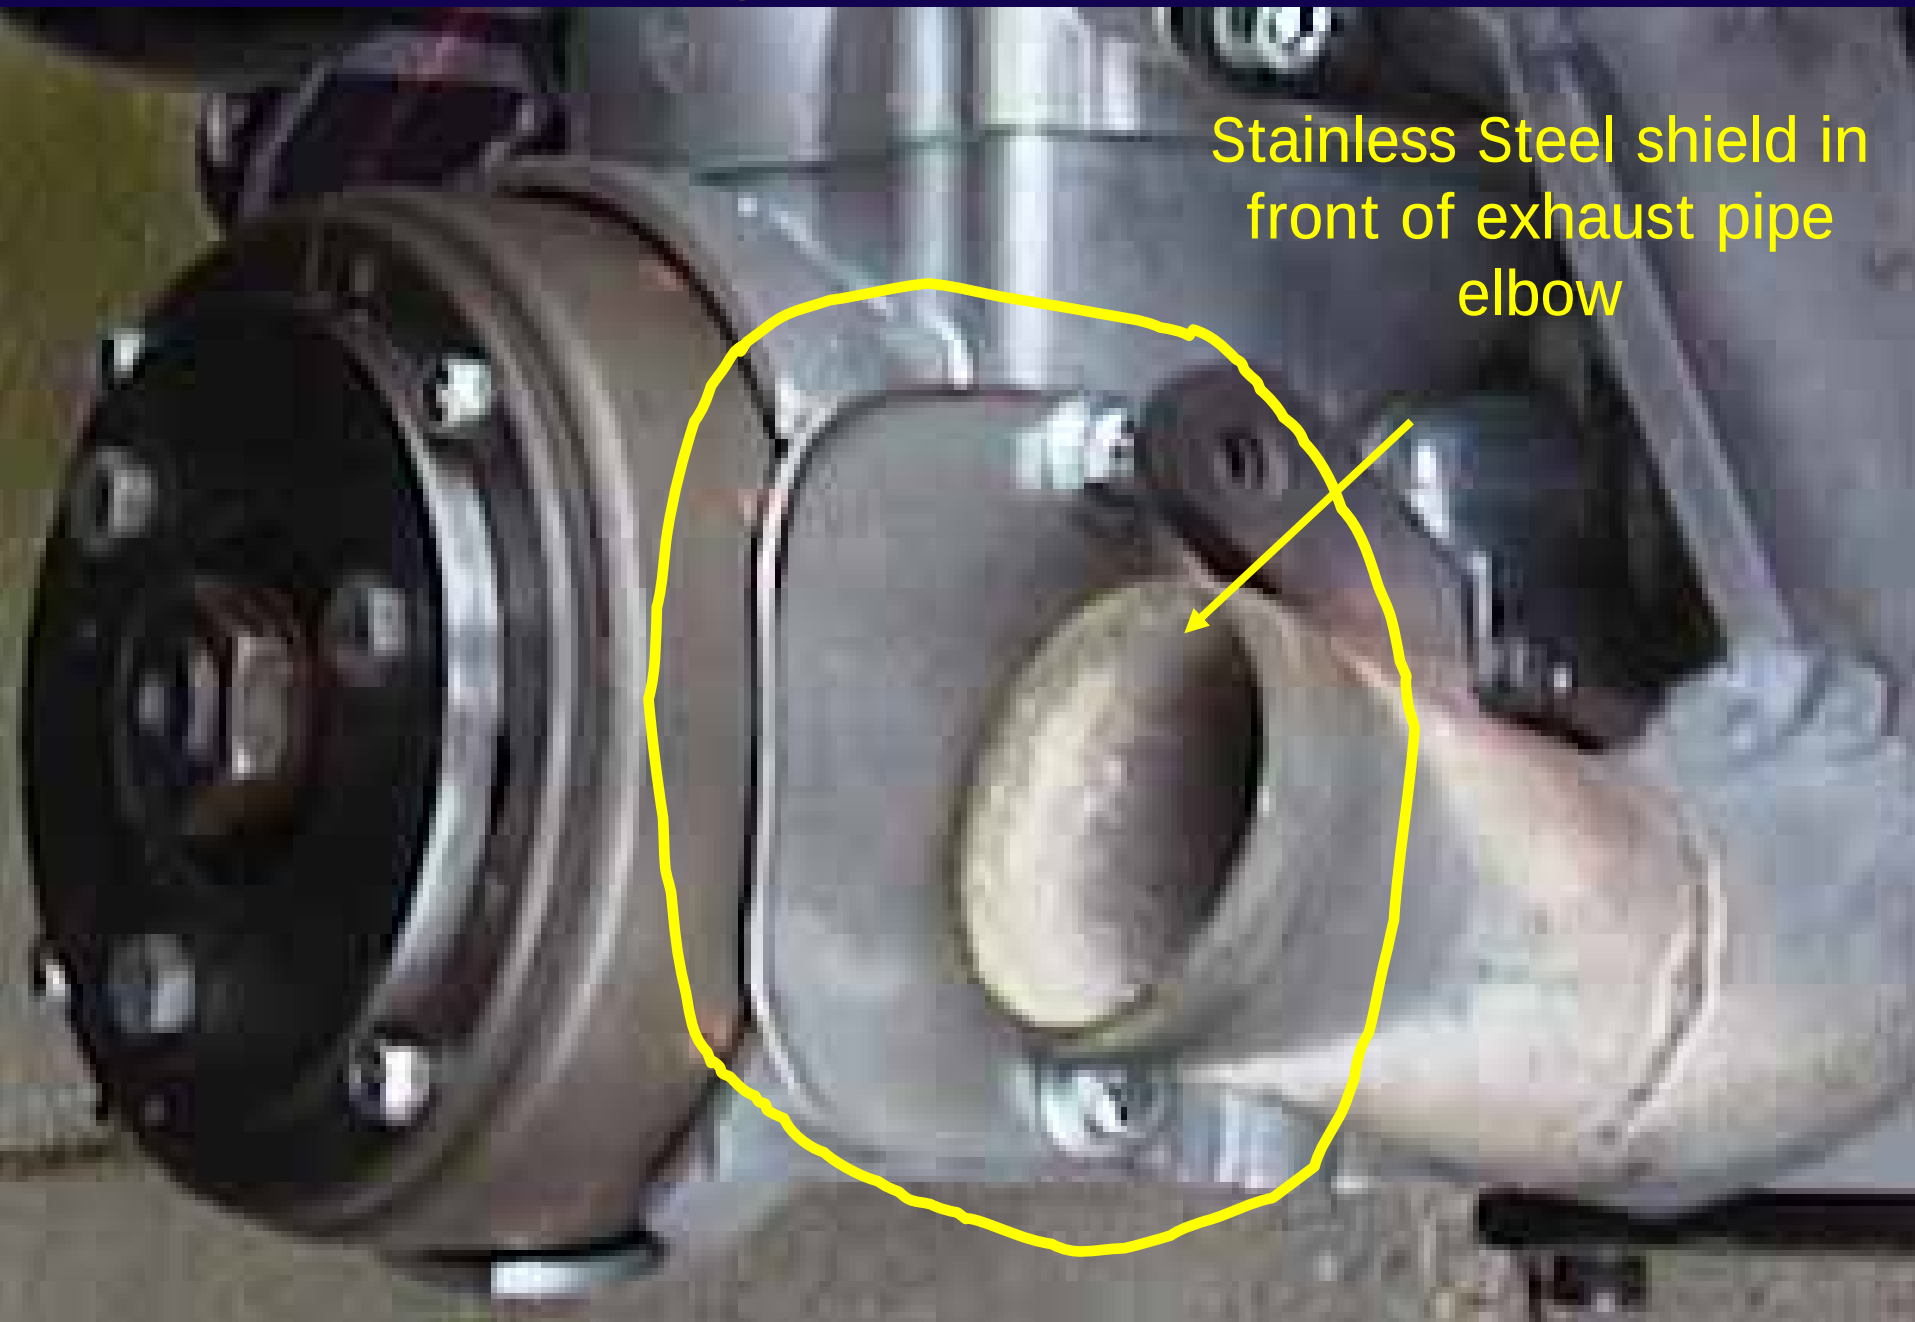
Rotax 535 Ignition Case Cut

Rotax 535 Ignition Case Cut Shield

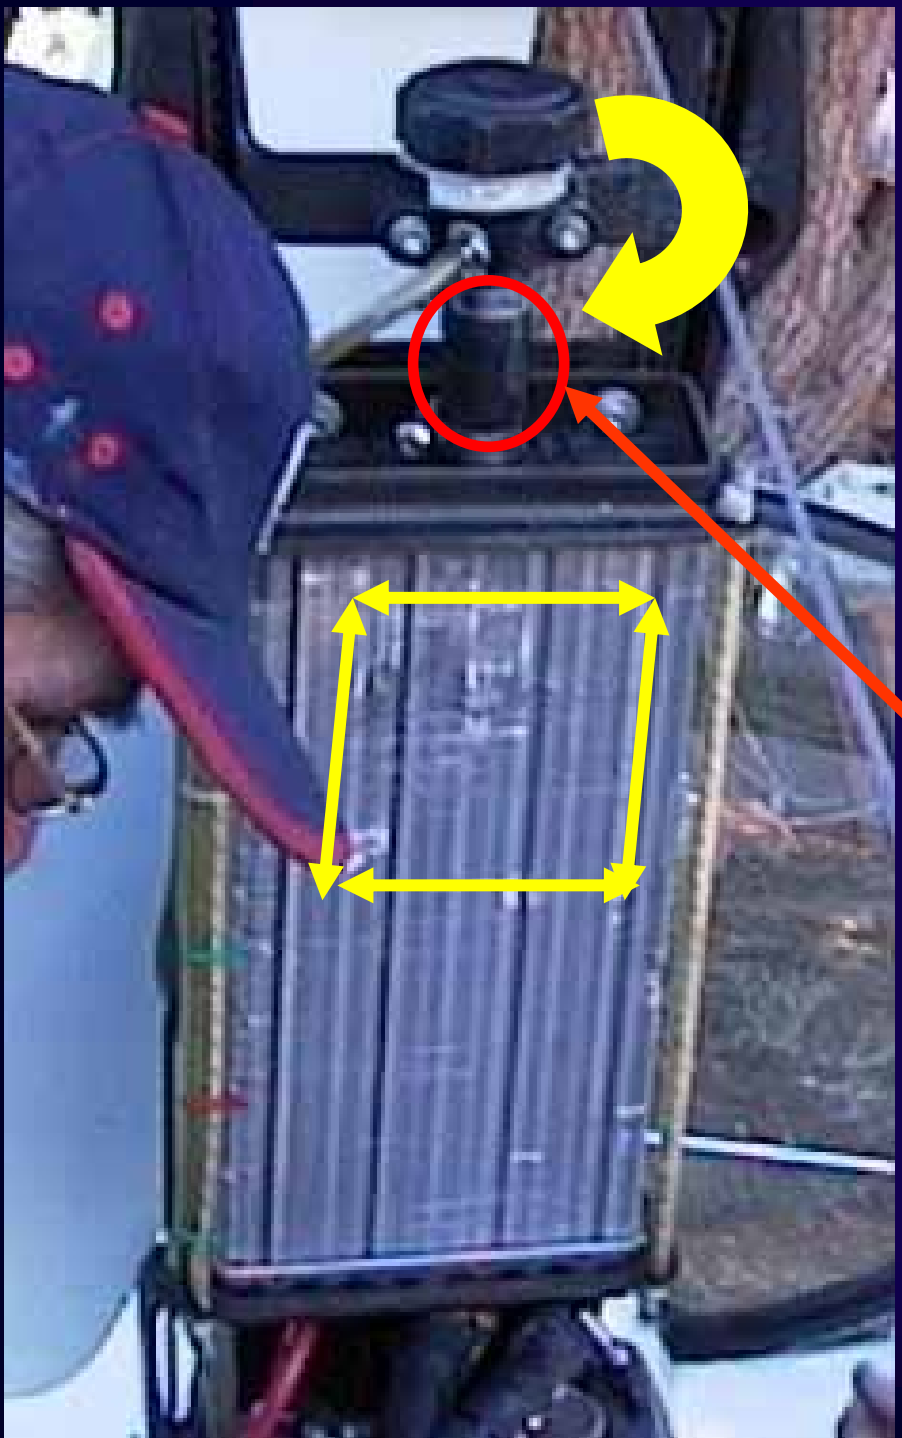
Cooling system:

The vibration planes of radiator and plug are perpendicular

= breakage of the rubber hose! Very dangerous.

Always a spare on board!

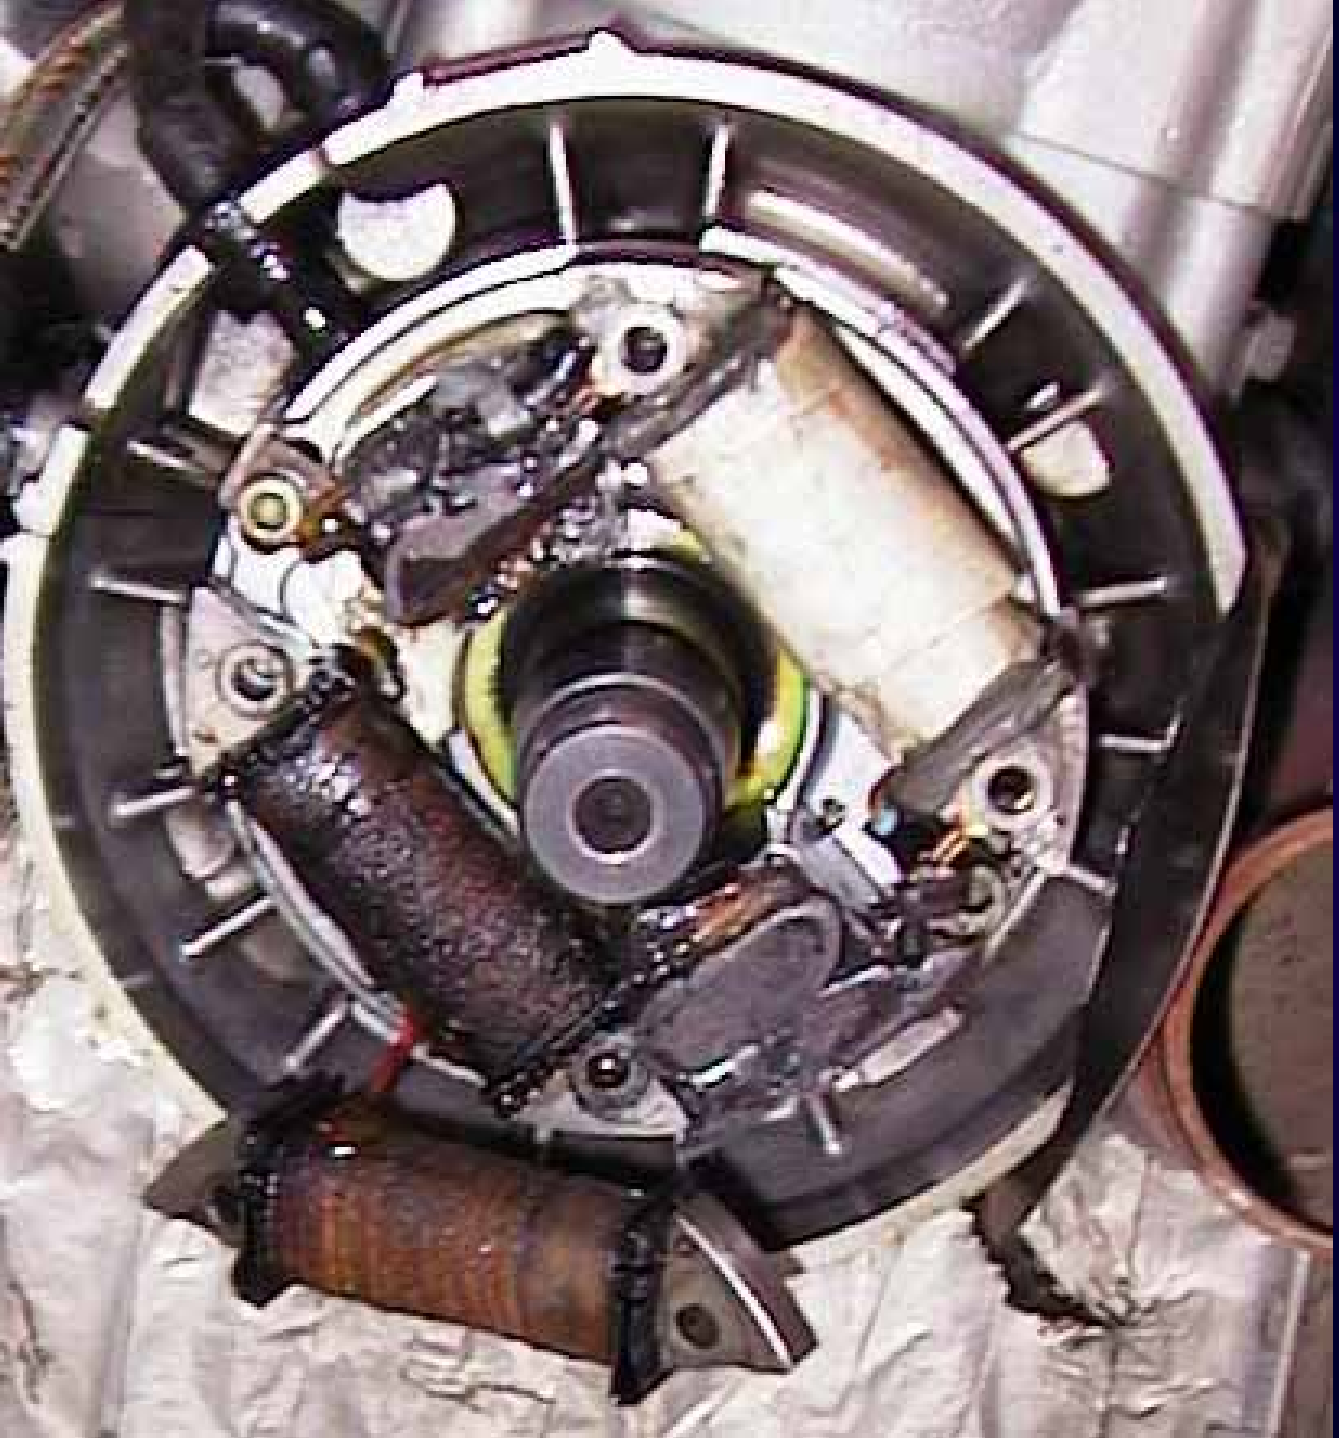
Coils (generator and ignition) have burnt out several times

Heat and

vibrations

Rotax 535 iginition plate after 17 hours since revised at SHK.

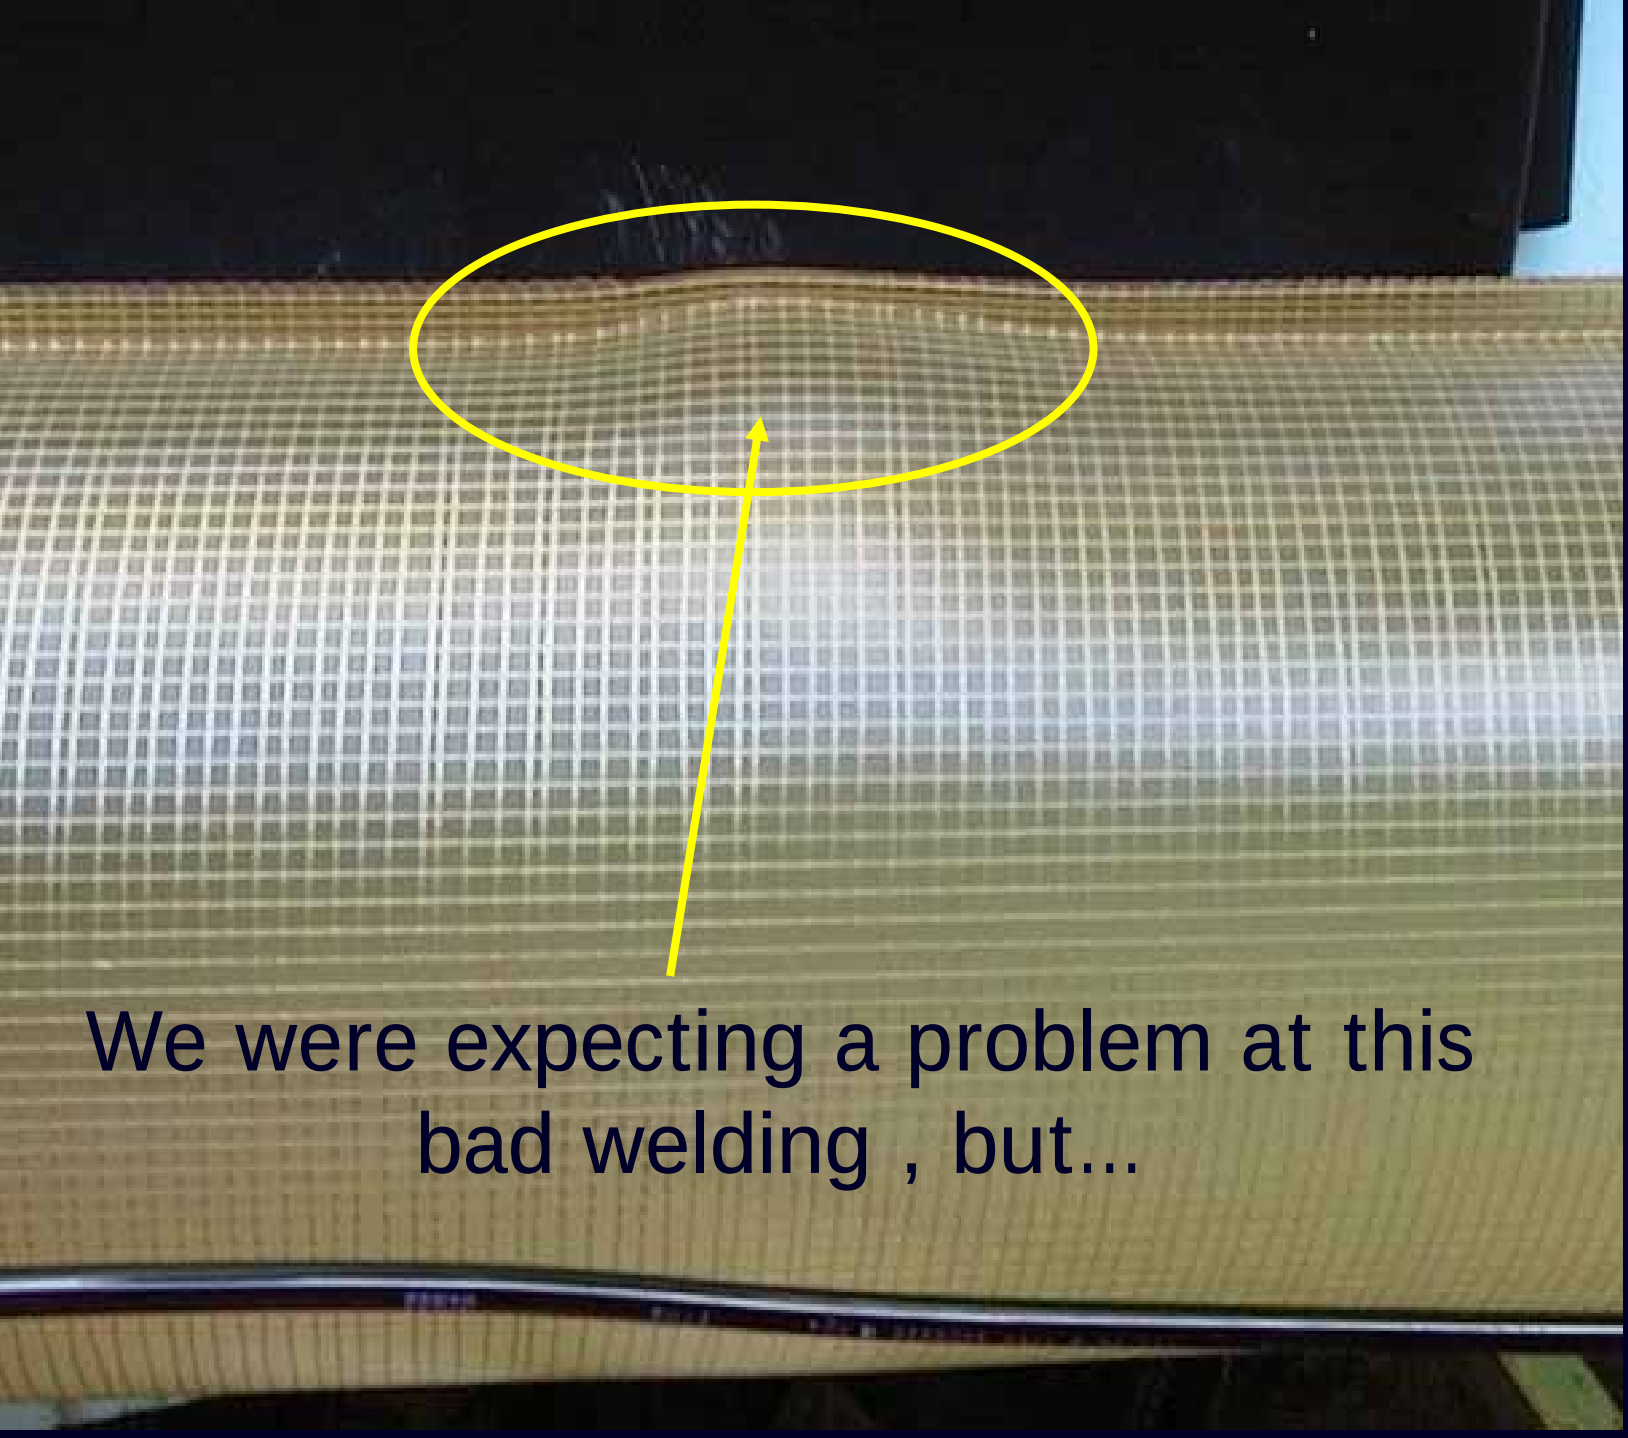
PRESSURE TEST

According to the manufacturer

at 1,5 mWC pressure

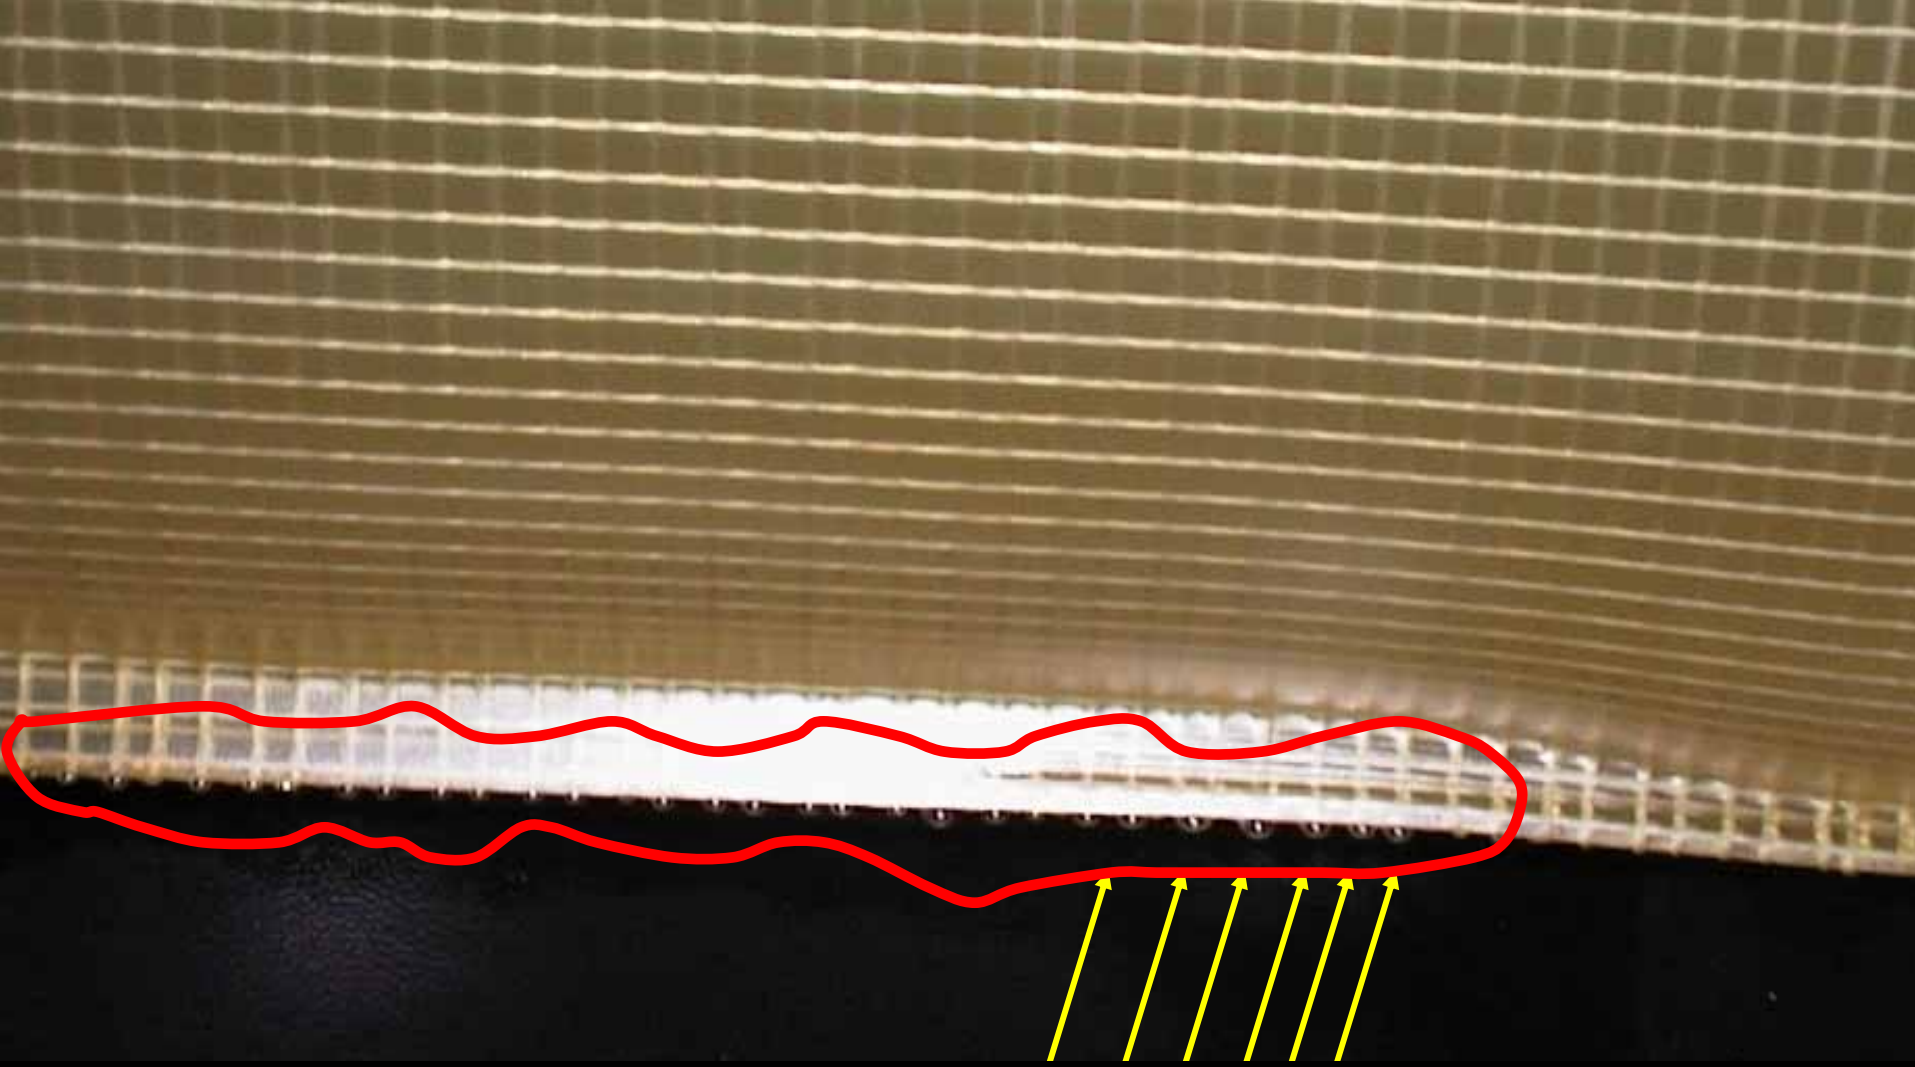
We were expecting a problem at this bad welding , but...
