Motorized Sailplanes

20 Years of Joy and Pain

Brief History of Personal Experience since 1986

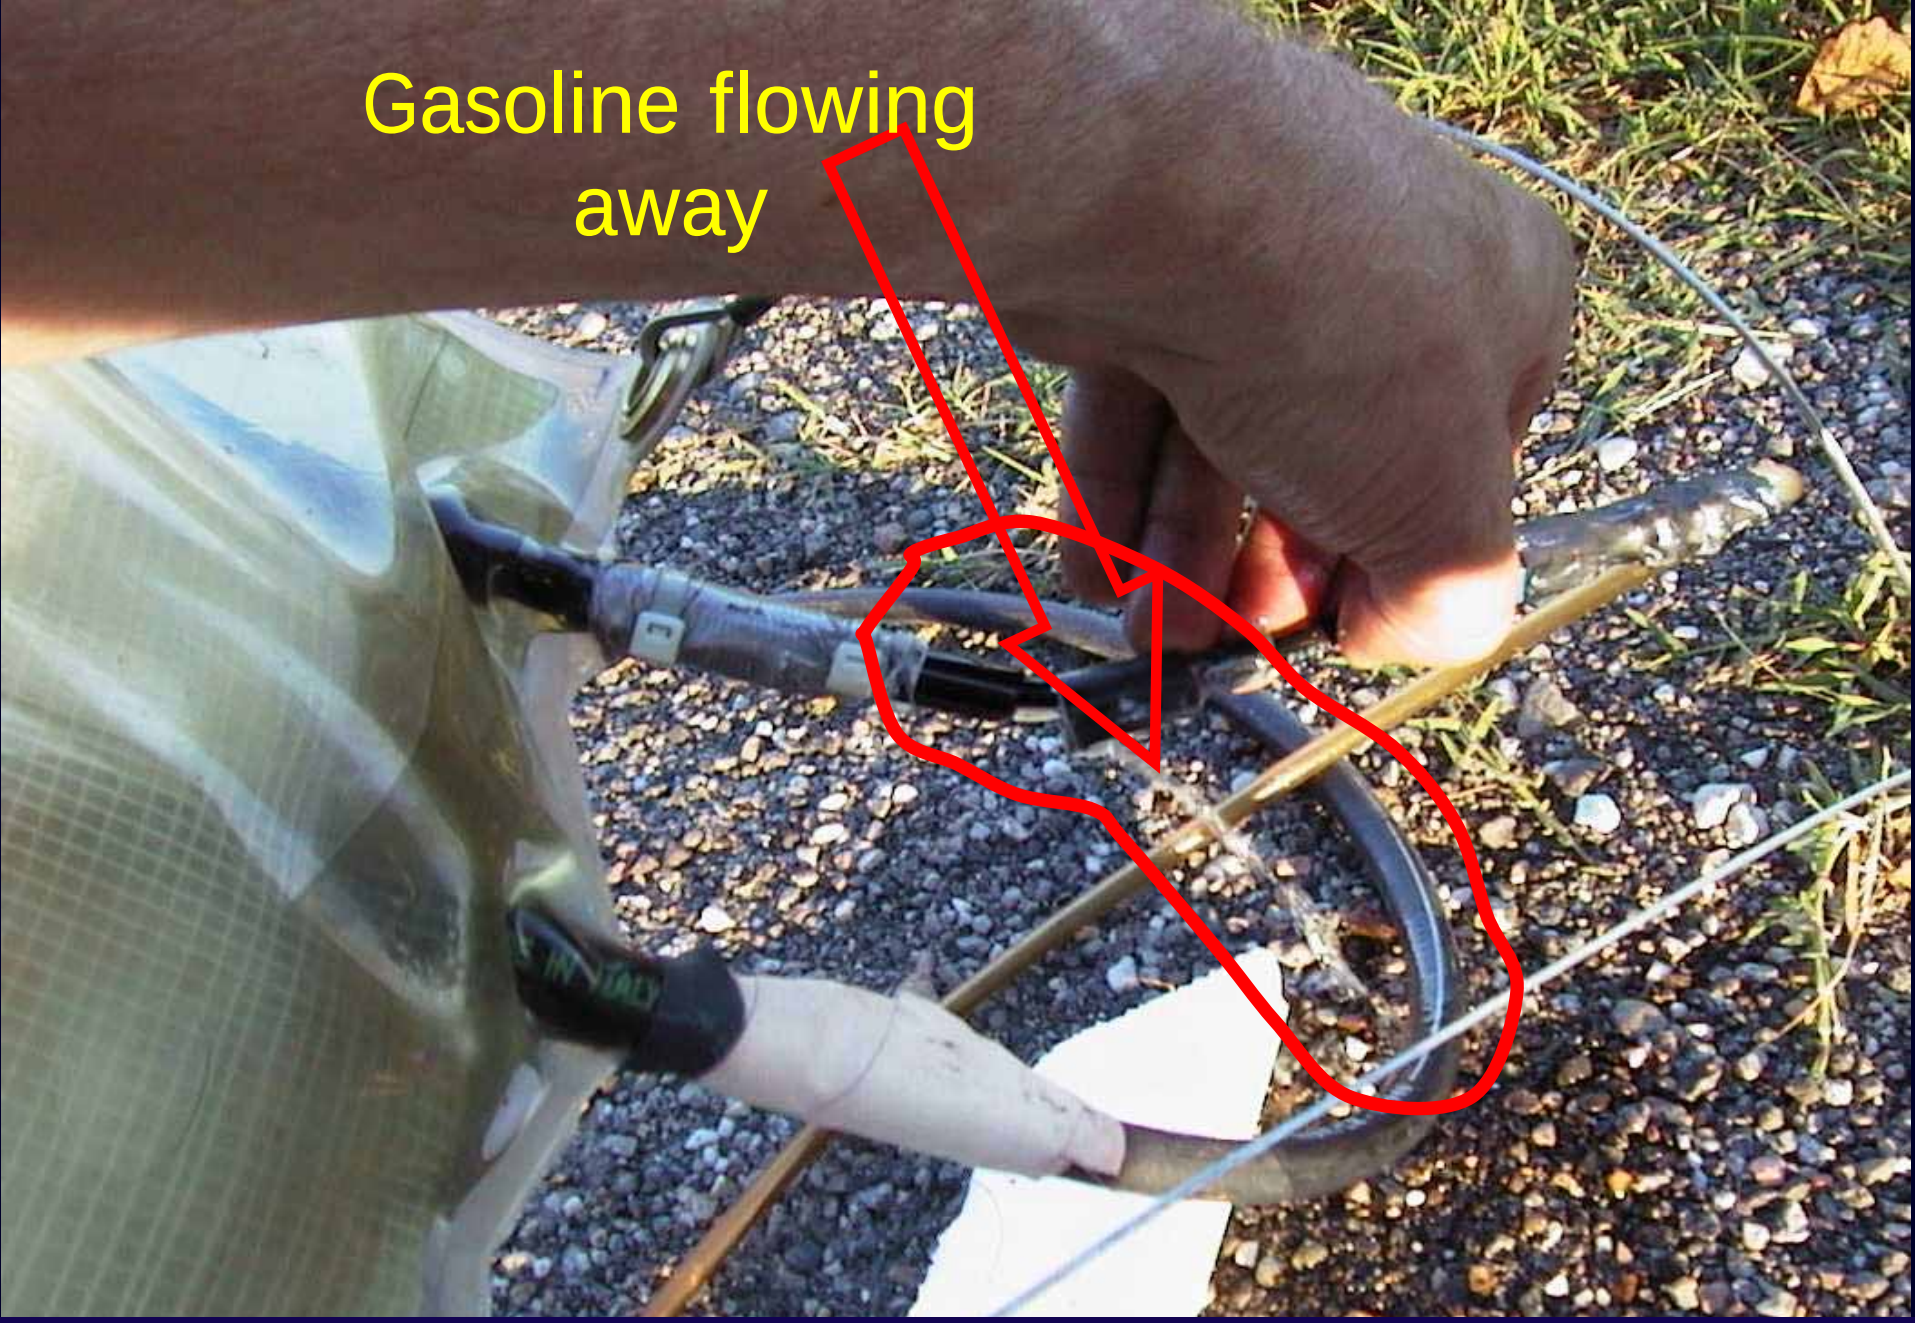
Every reinforcing yarn was leaking.

A drop can be seen on each one, except on the bad weld!

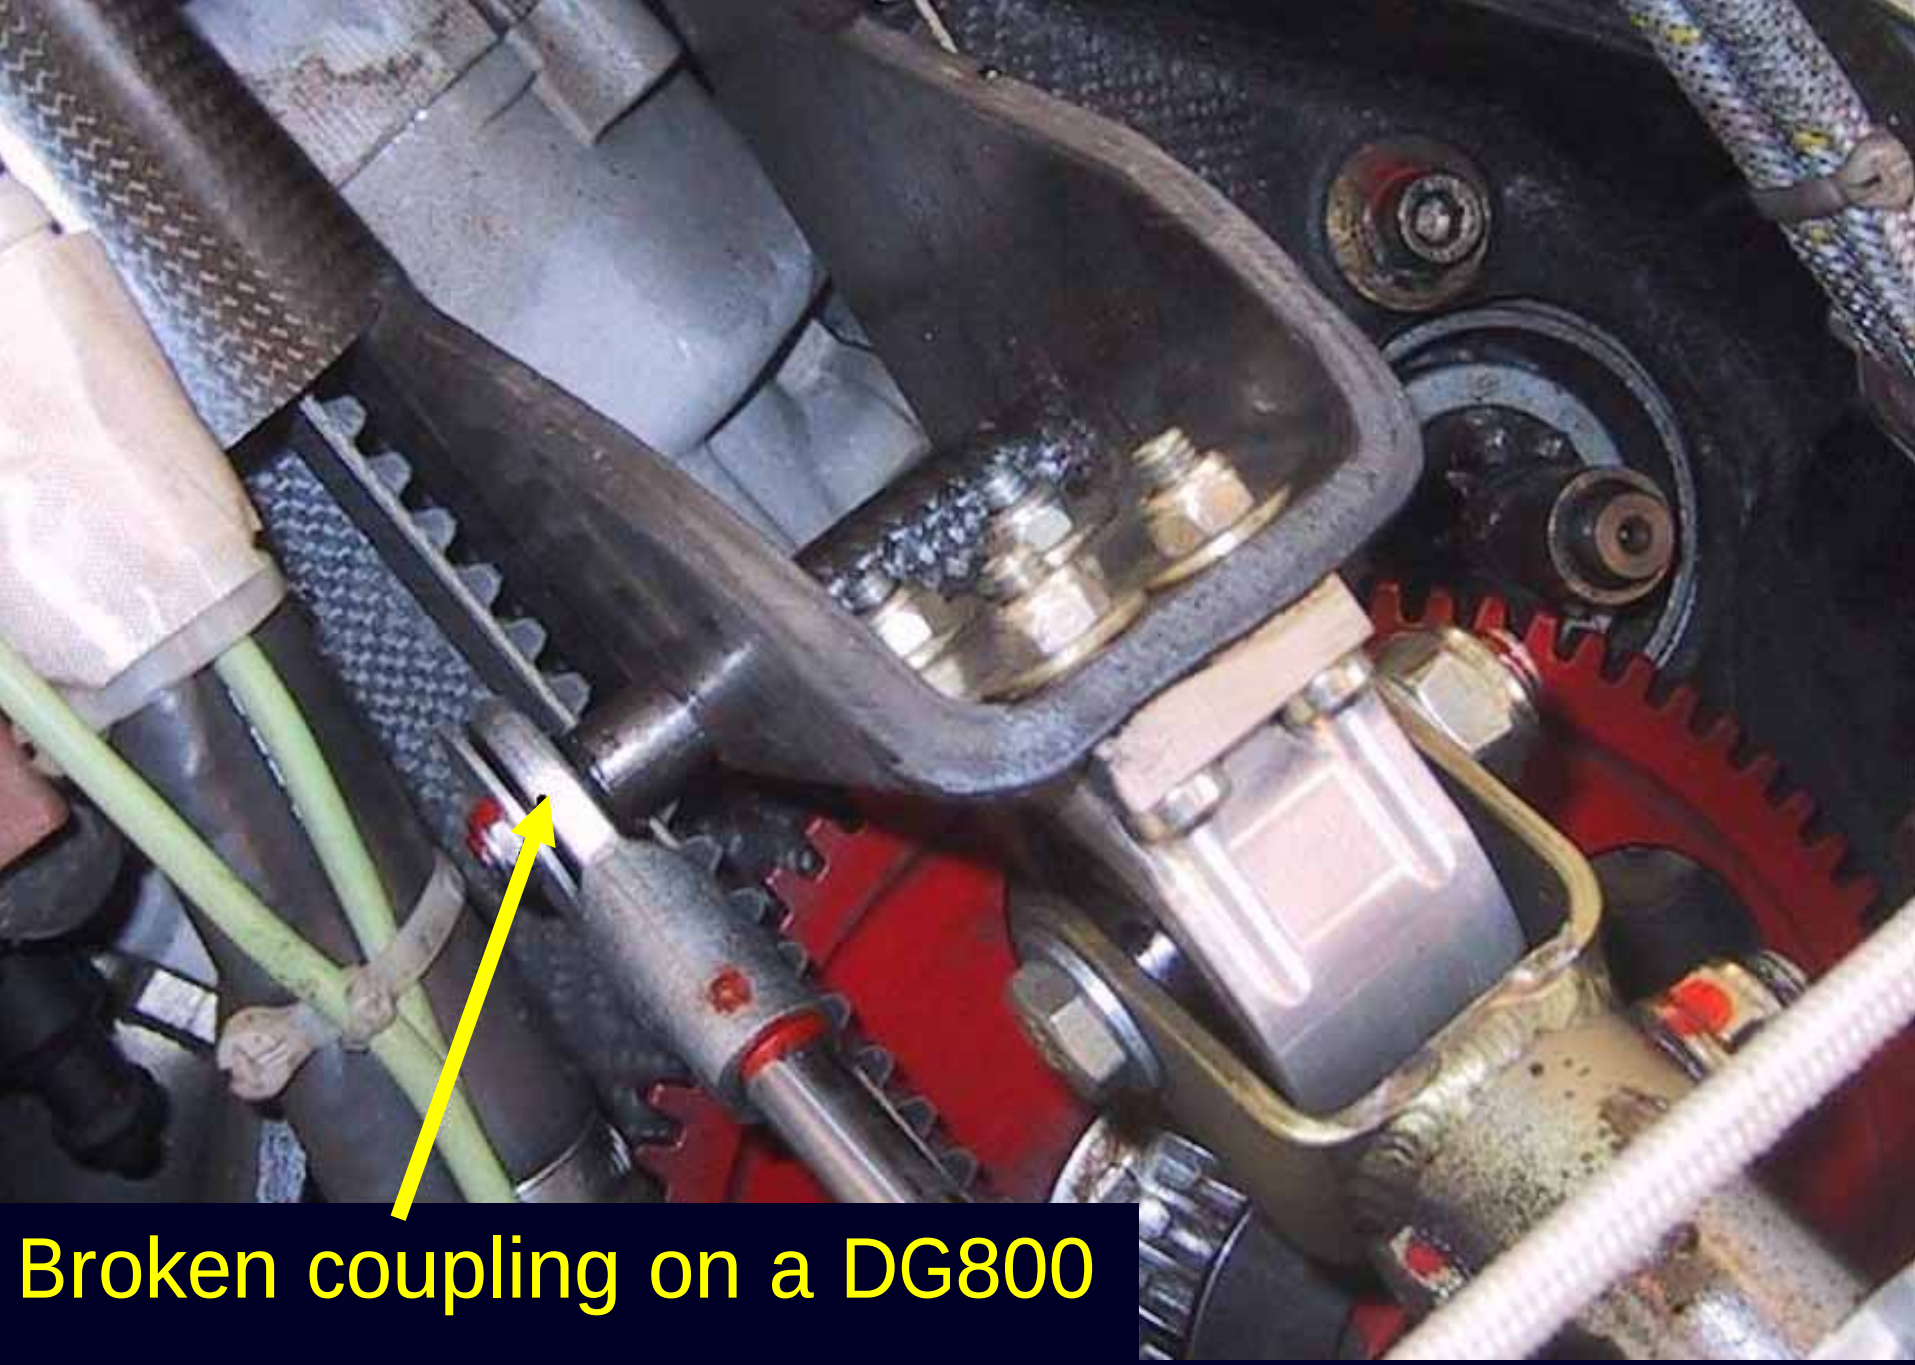
Broken coupling on a DG800

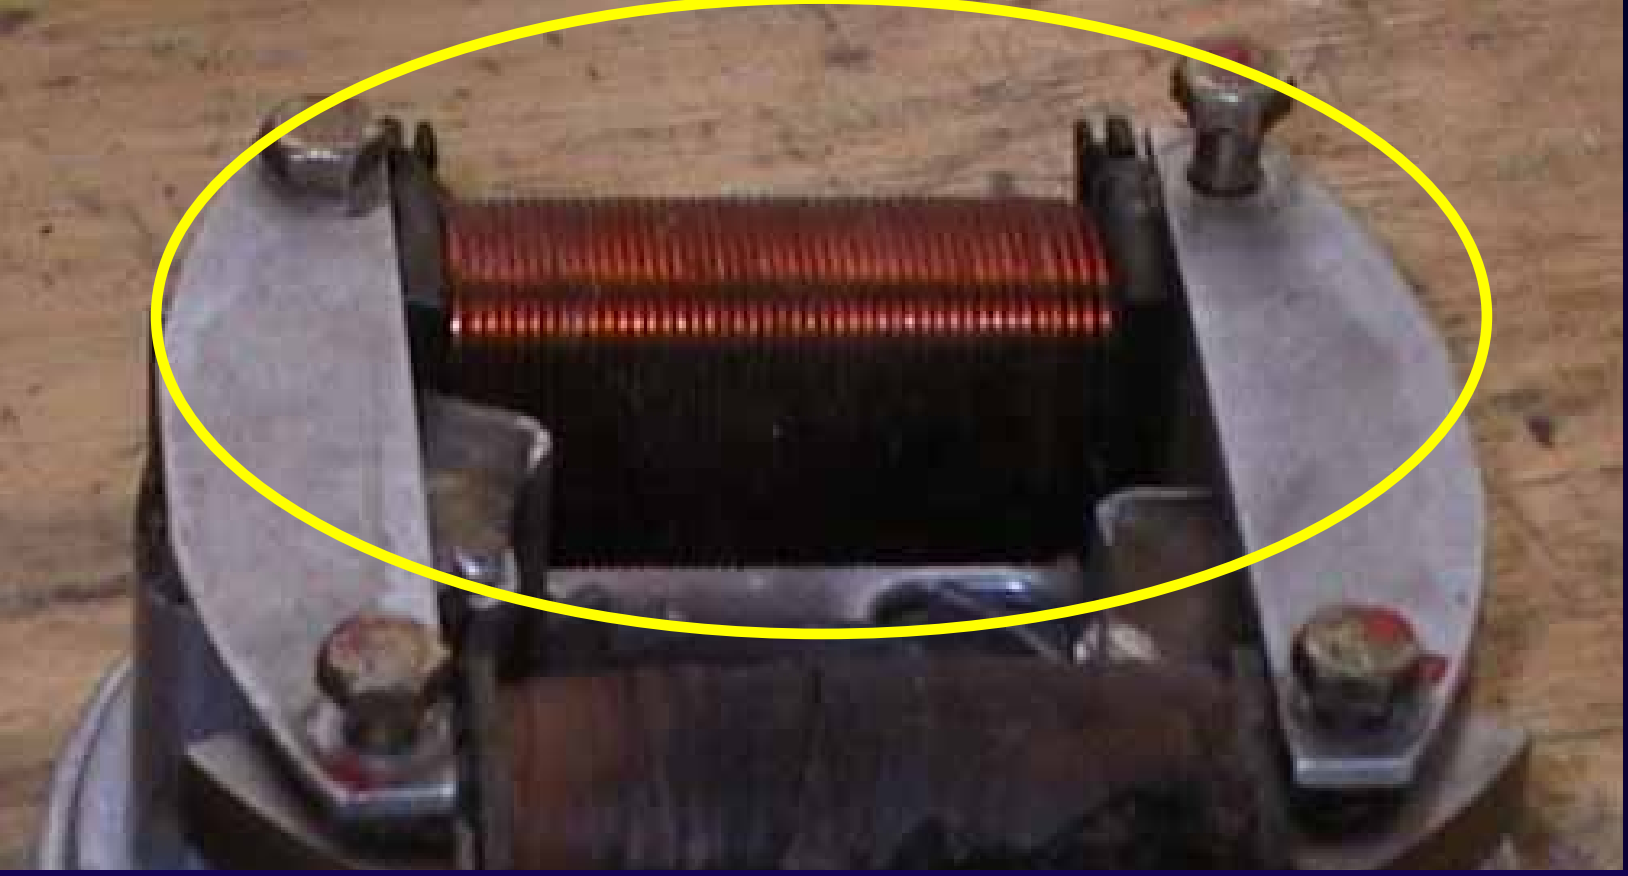
- The generator coil is submitted to the same vibrations and heat than the ignition coils. Same result:
  - 2 failures in 120 hours with Rotax
  - 1 failure after 10 hours with Solo

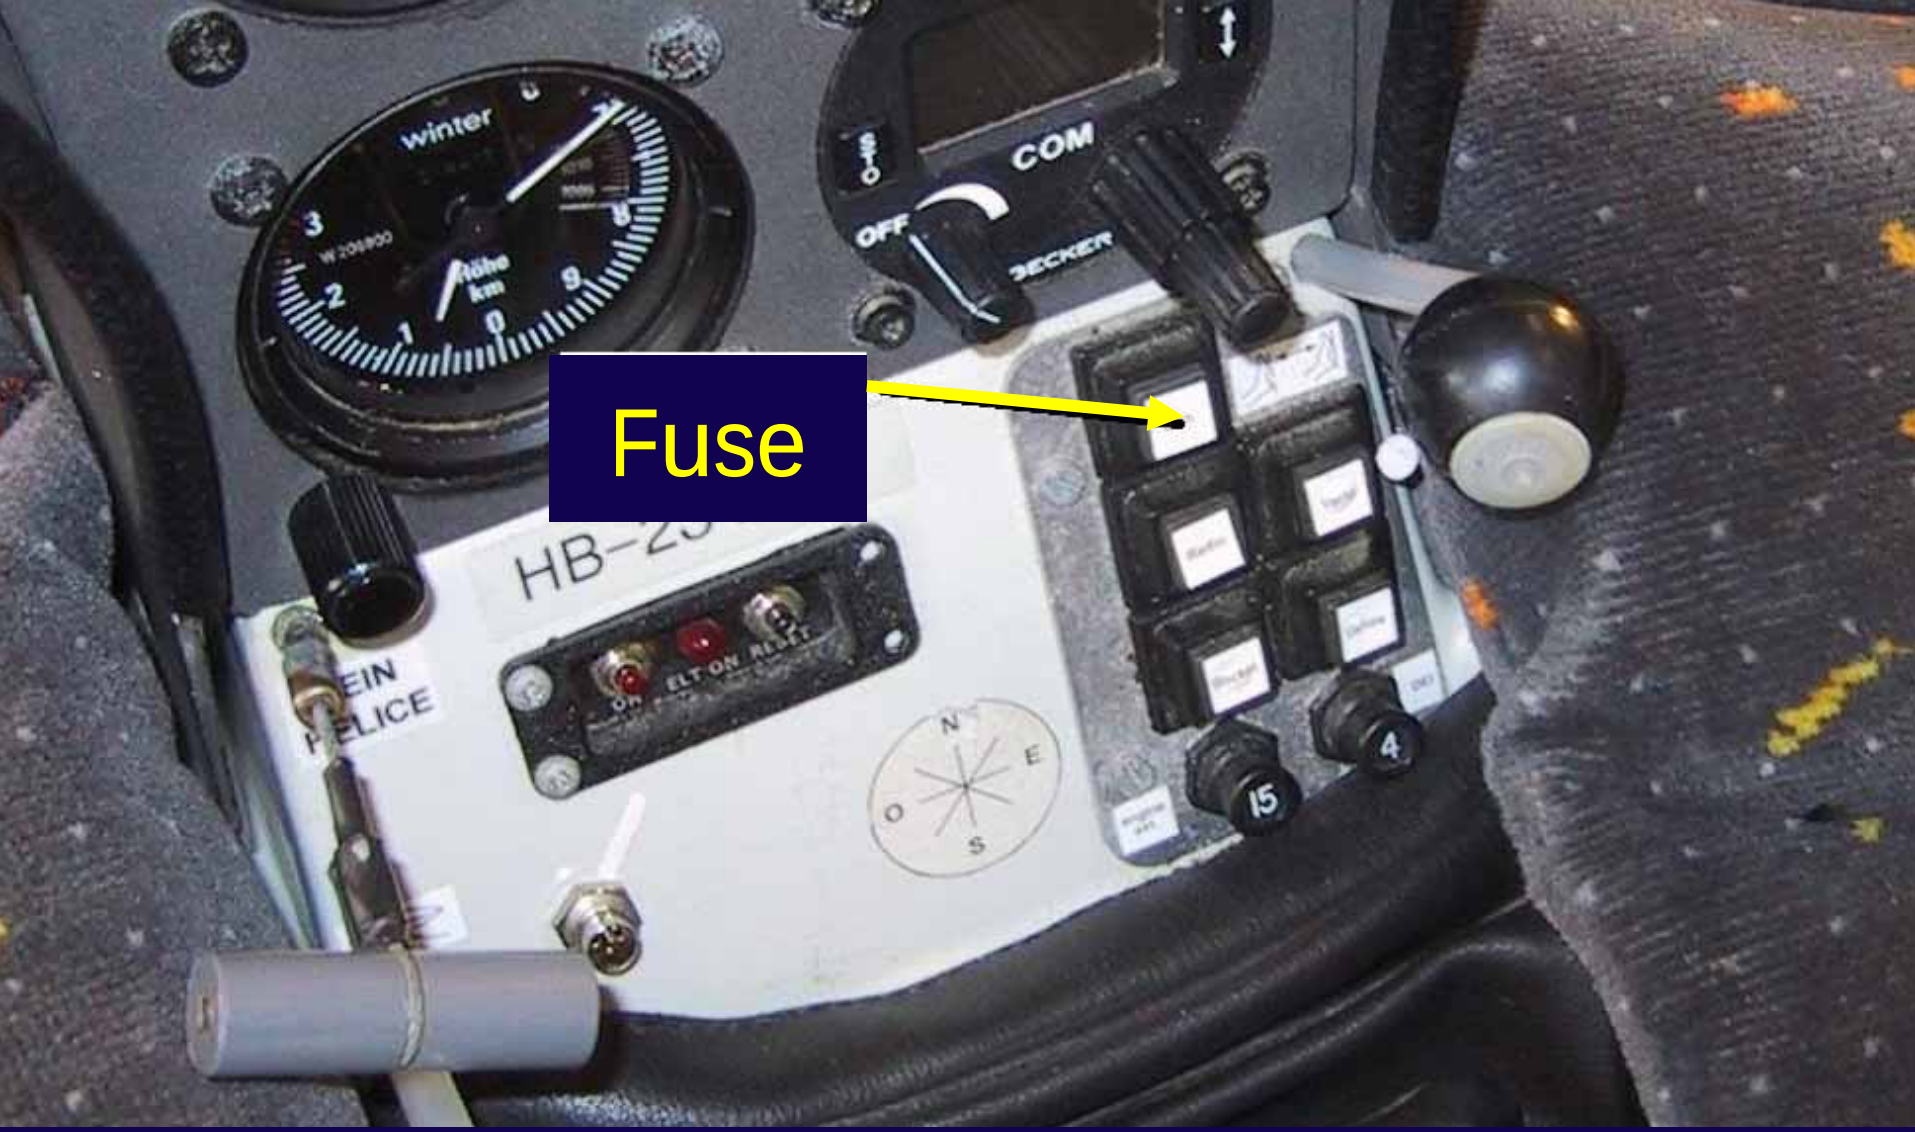
DG 800: the same fuse is used for charging in flight and on the ground: no more charging possible.
Engine may not move!

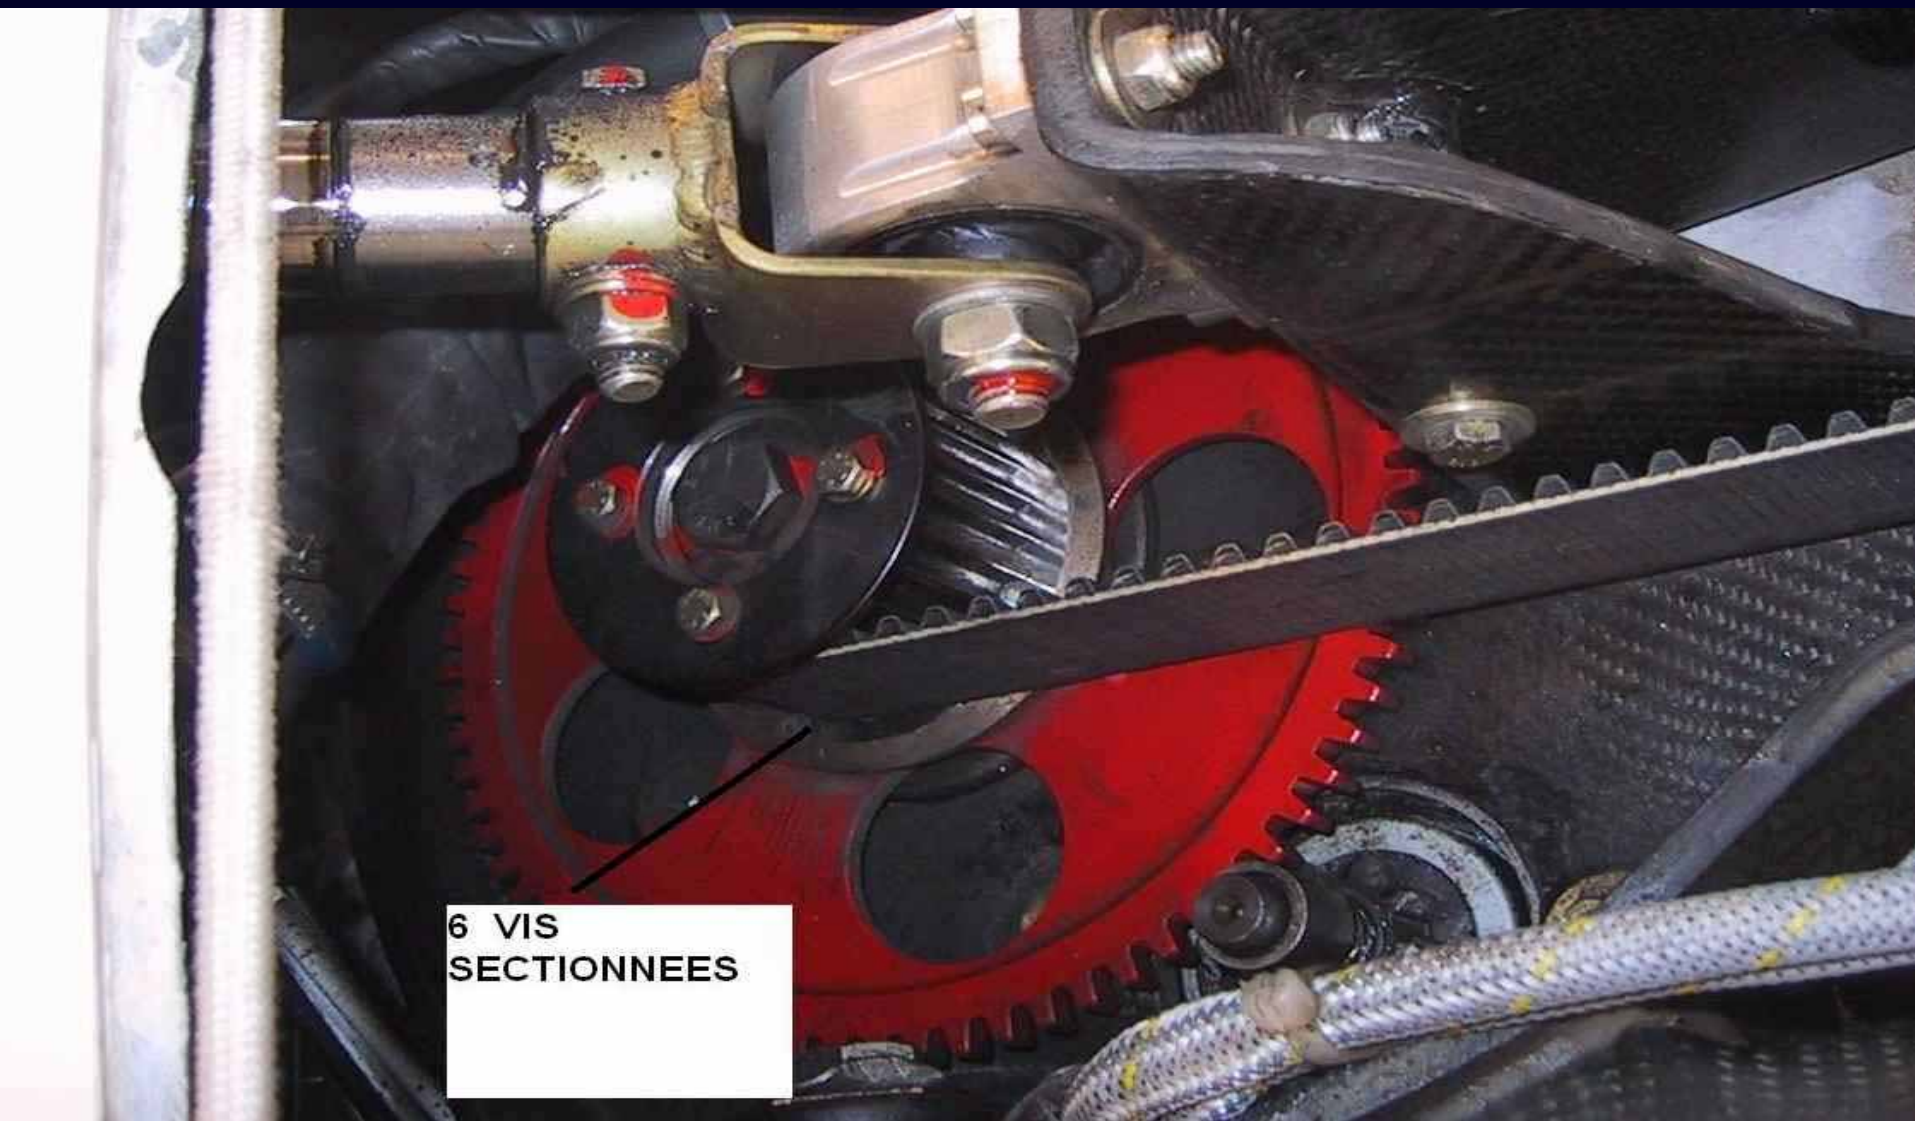
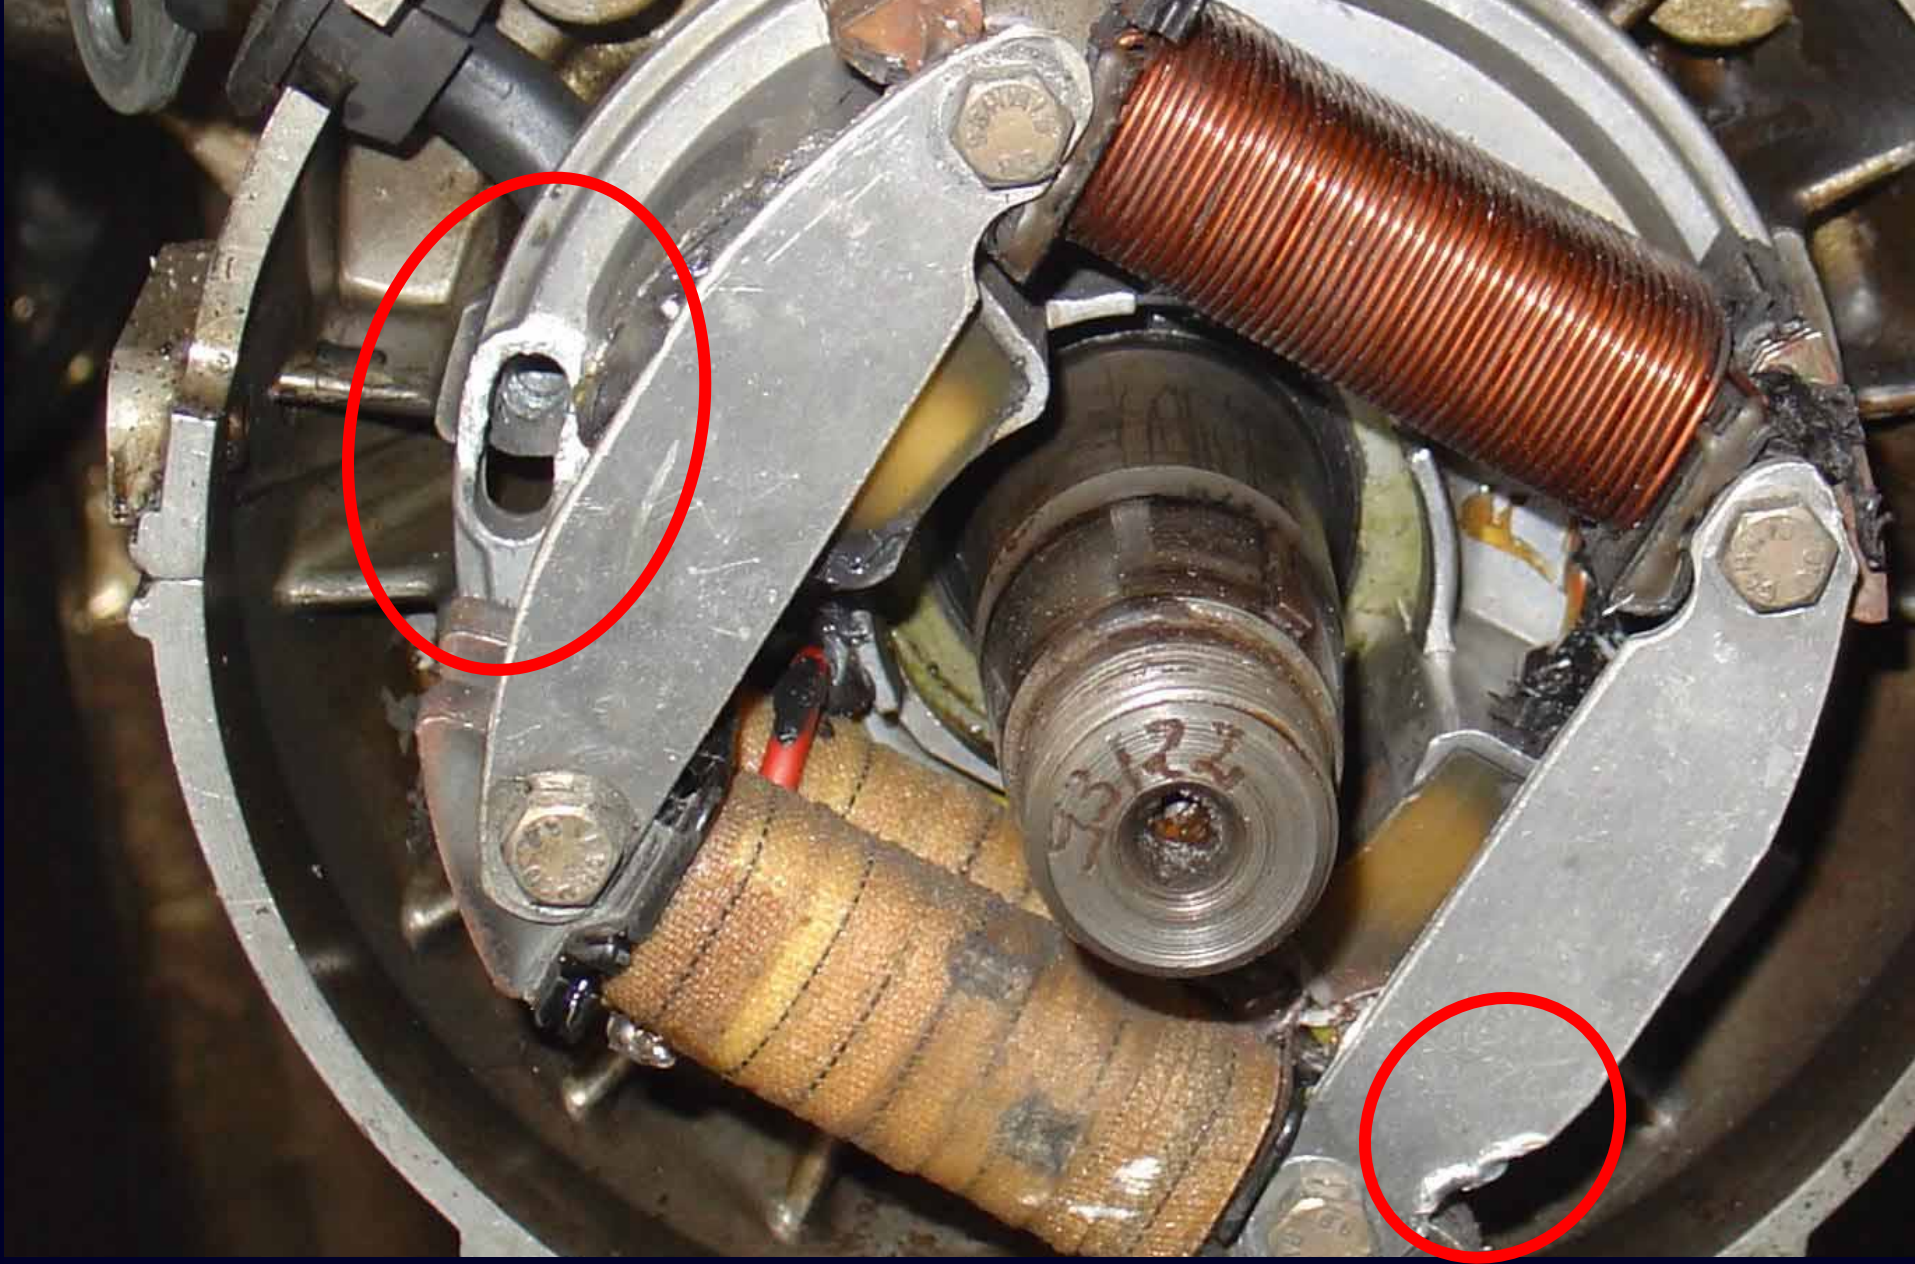
The gear was painted before tightening the screws: vibrations made all unscrewed away, gear lost.

Engine back from Total Overhaul by German “certifed” workshop: timing screws unsecured went away, glider grounded for months
